From: Michael Behrendt
Sent: Tuesday, July 24, 2018 4:39 PM
Subject: Eversource - tree cutting - updated list of trees
Attachments: mfp_sender@ci.durham.nh.us_20180724_142625.pdf; ash tree 2.jpg; Ash tree.jpg; dead tree.jpg; ashs trees 4.jpg; Ash tree 3.jpg; Sycamore.jpg

To the Planning Board (and citizens who sent emails about the project), Mike Lynch, Bob Berner, Nick Fontaine (consulting forester with Bob Berner), and I drove around today to look at the trees proposed for removal by Eversource. Please note the following:

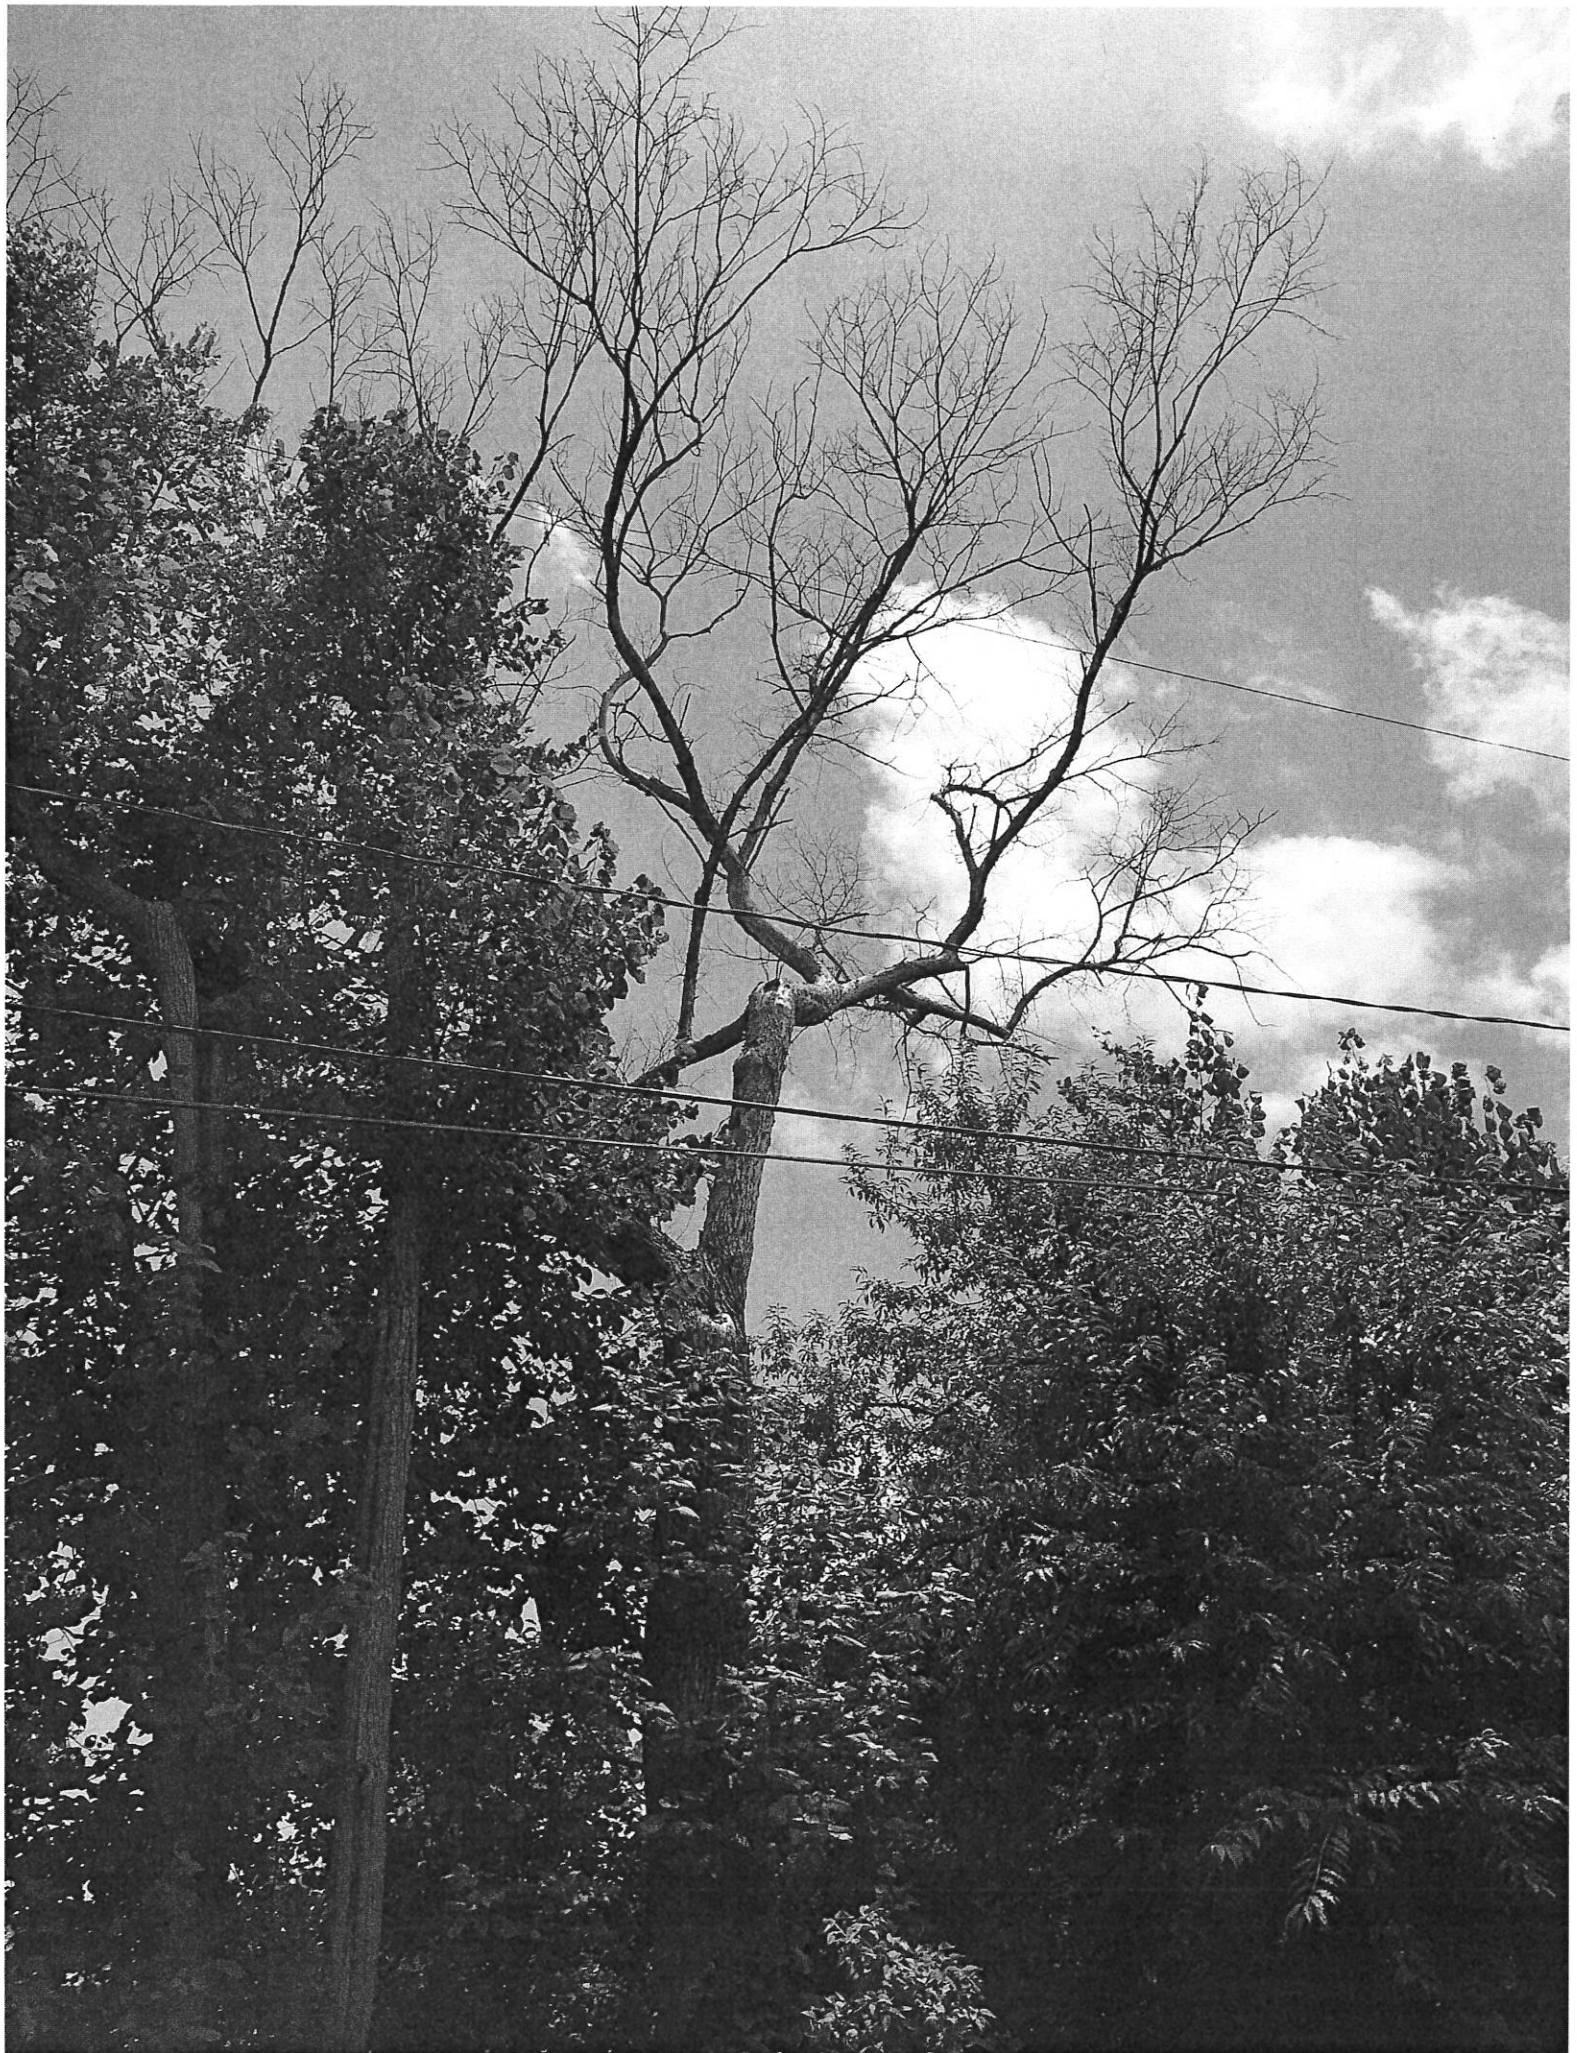
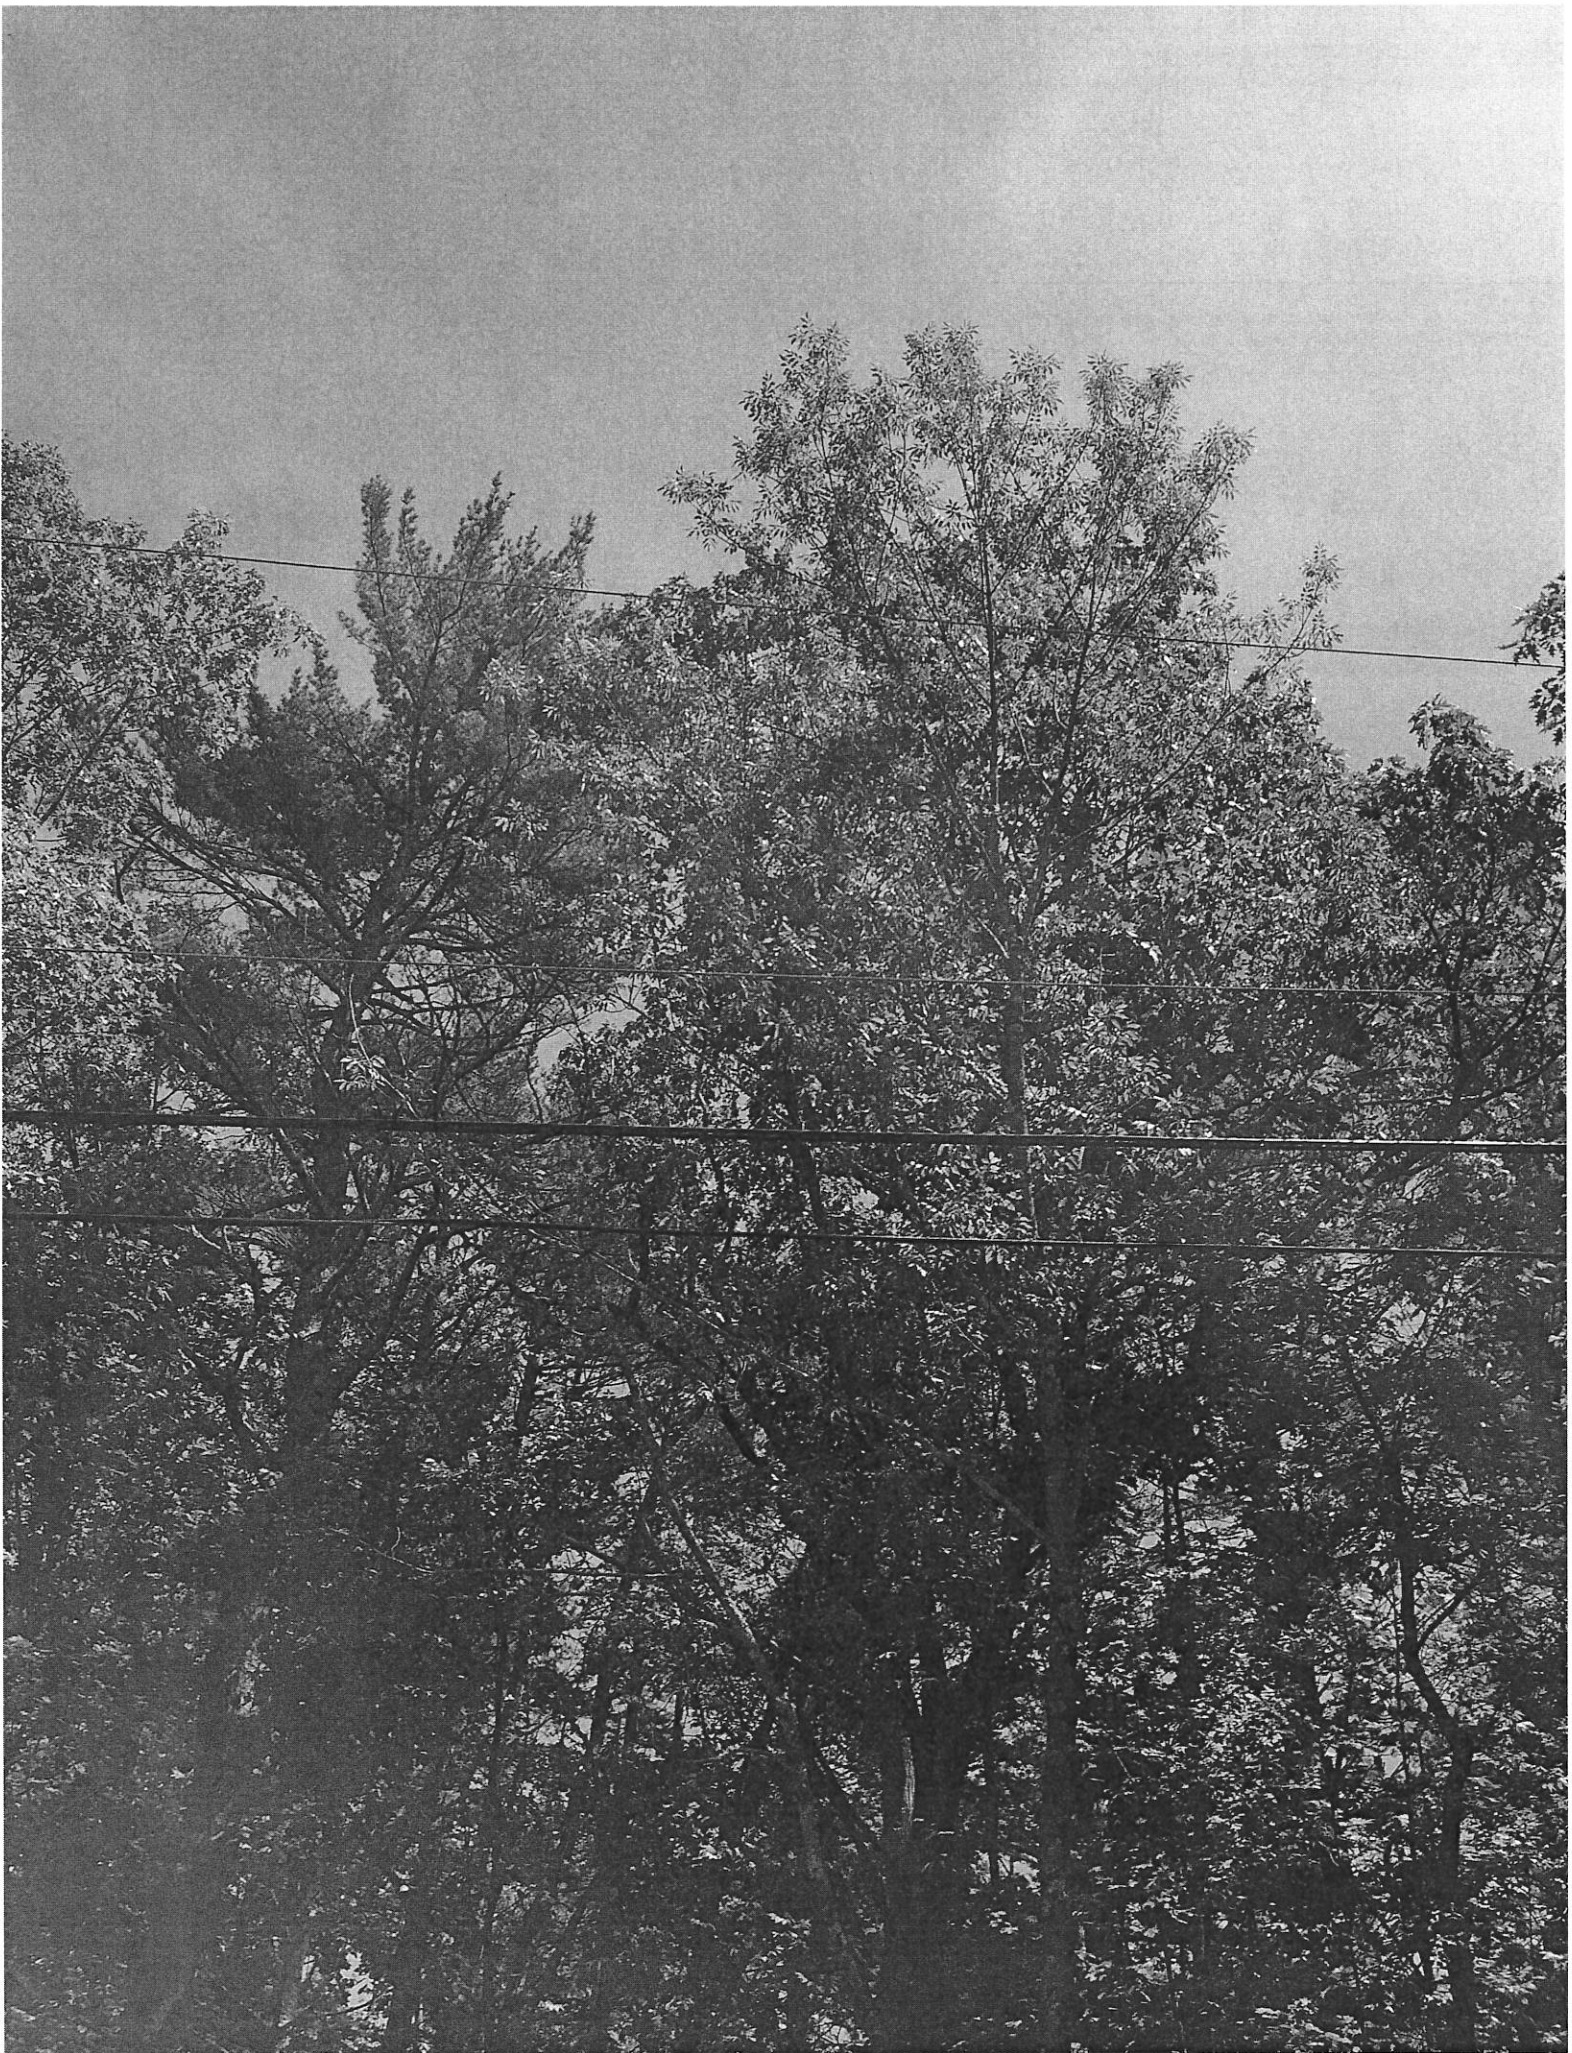
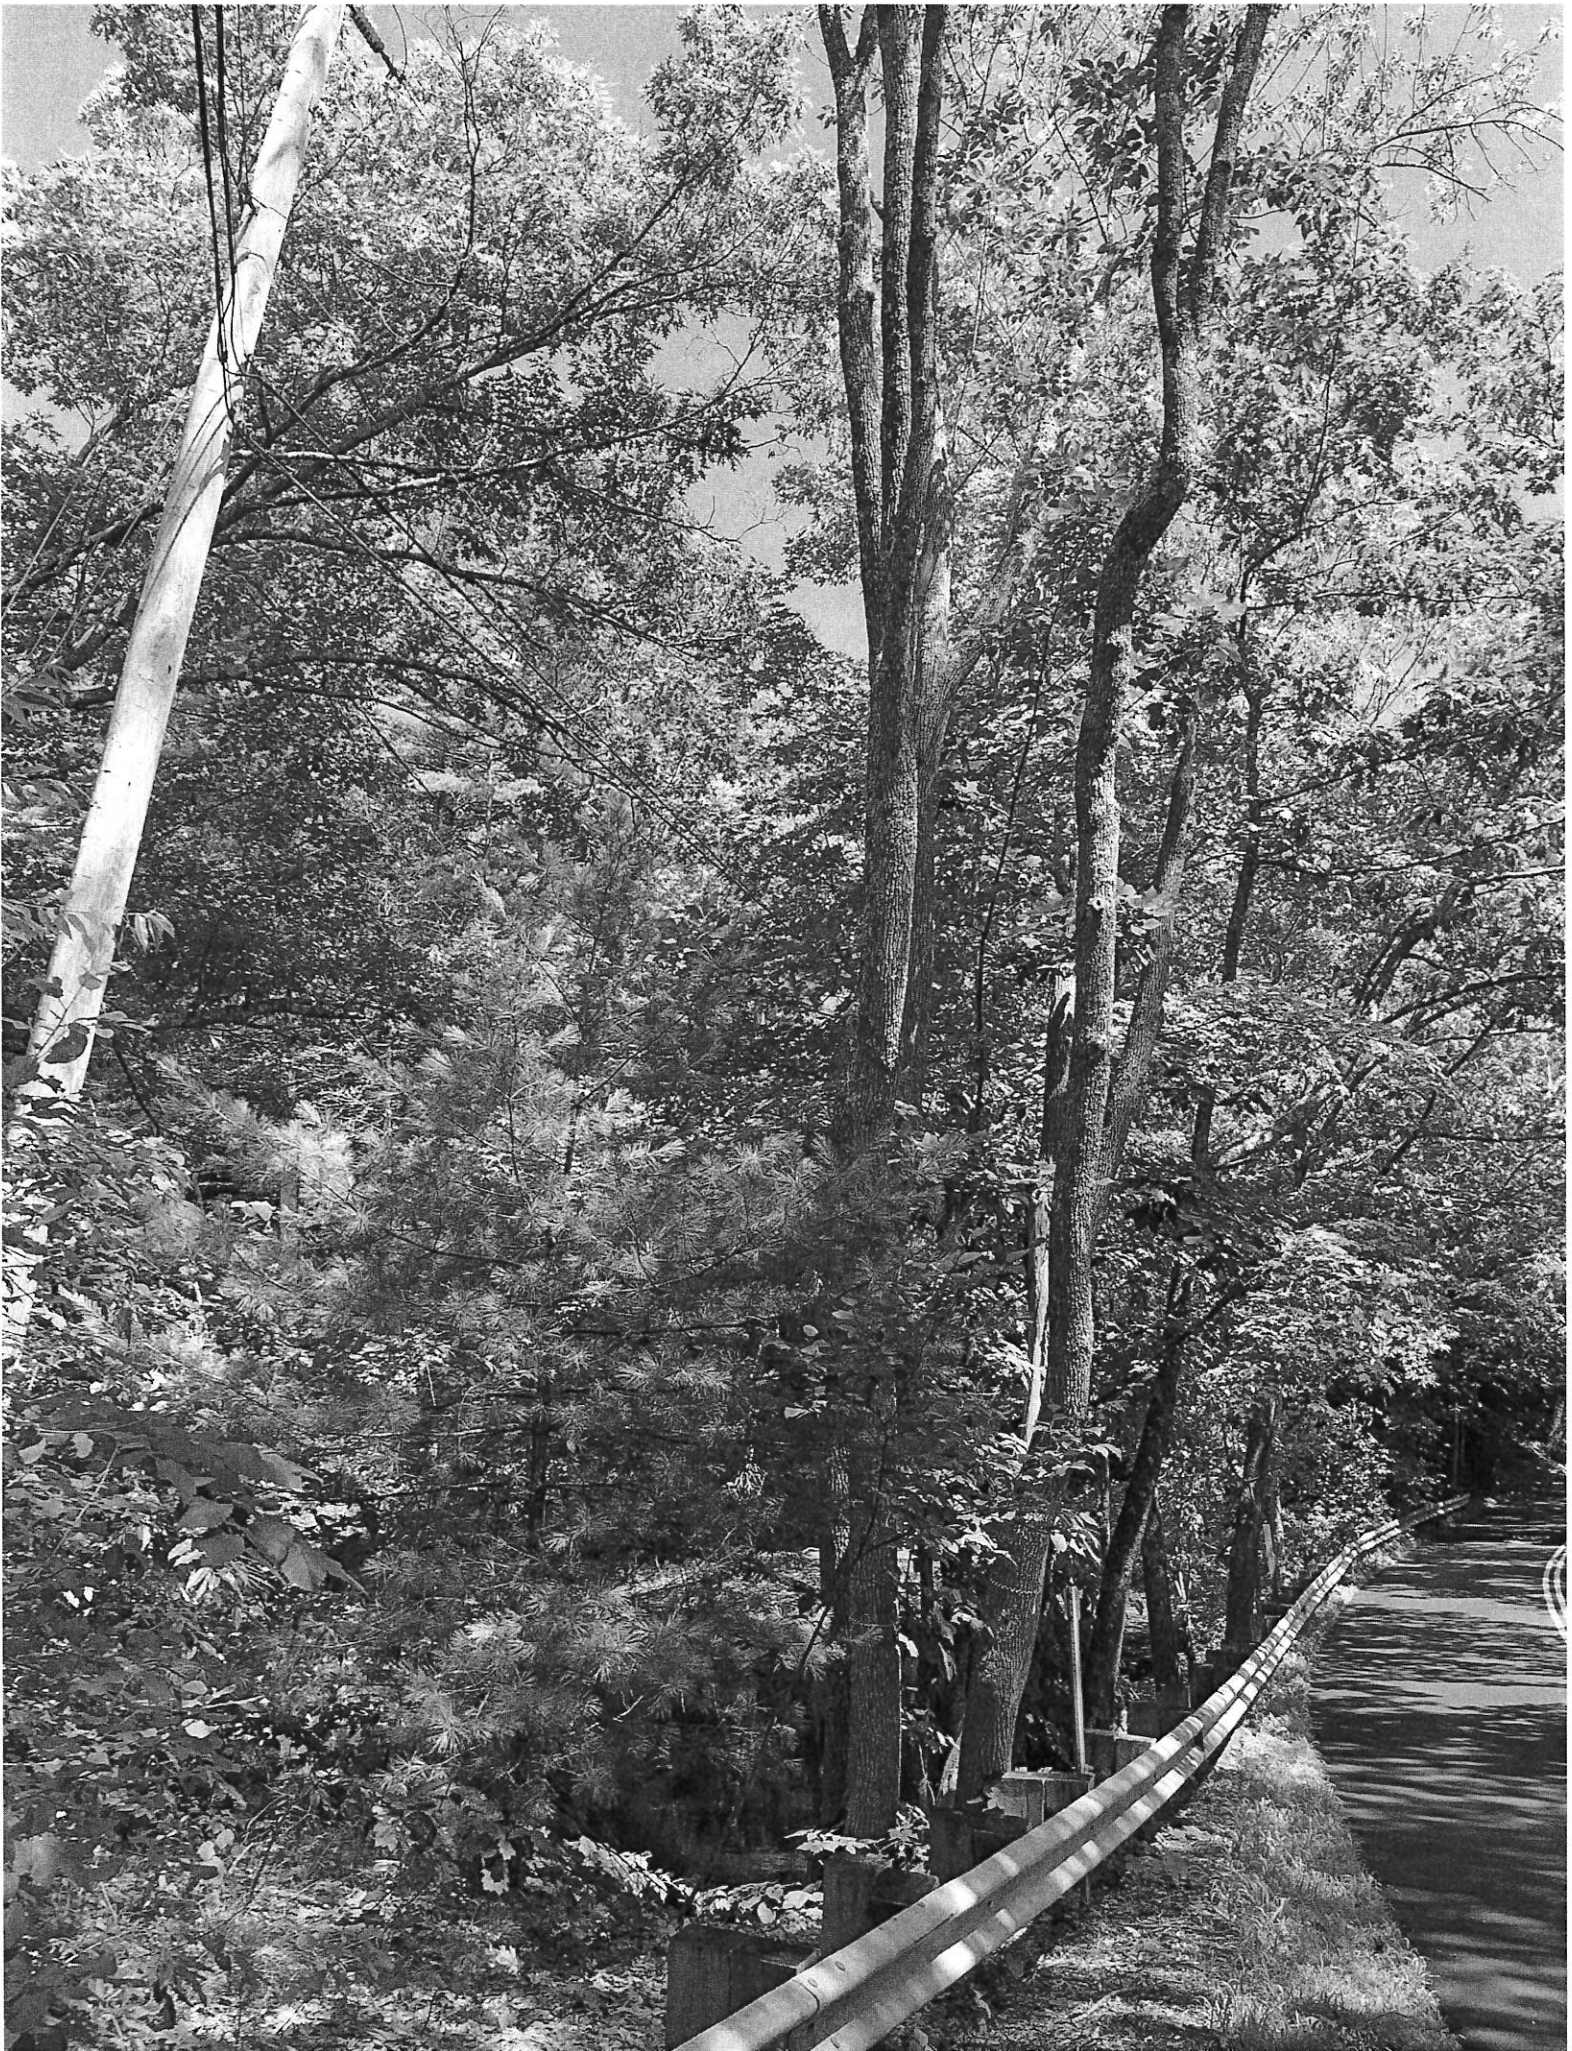
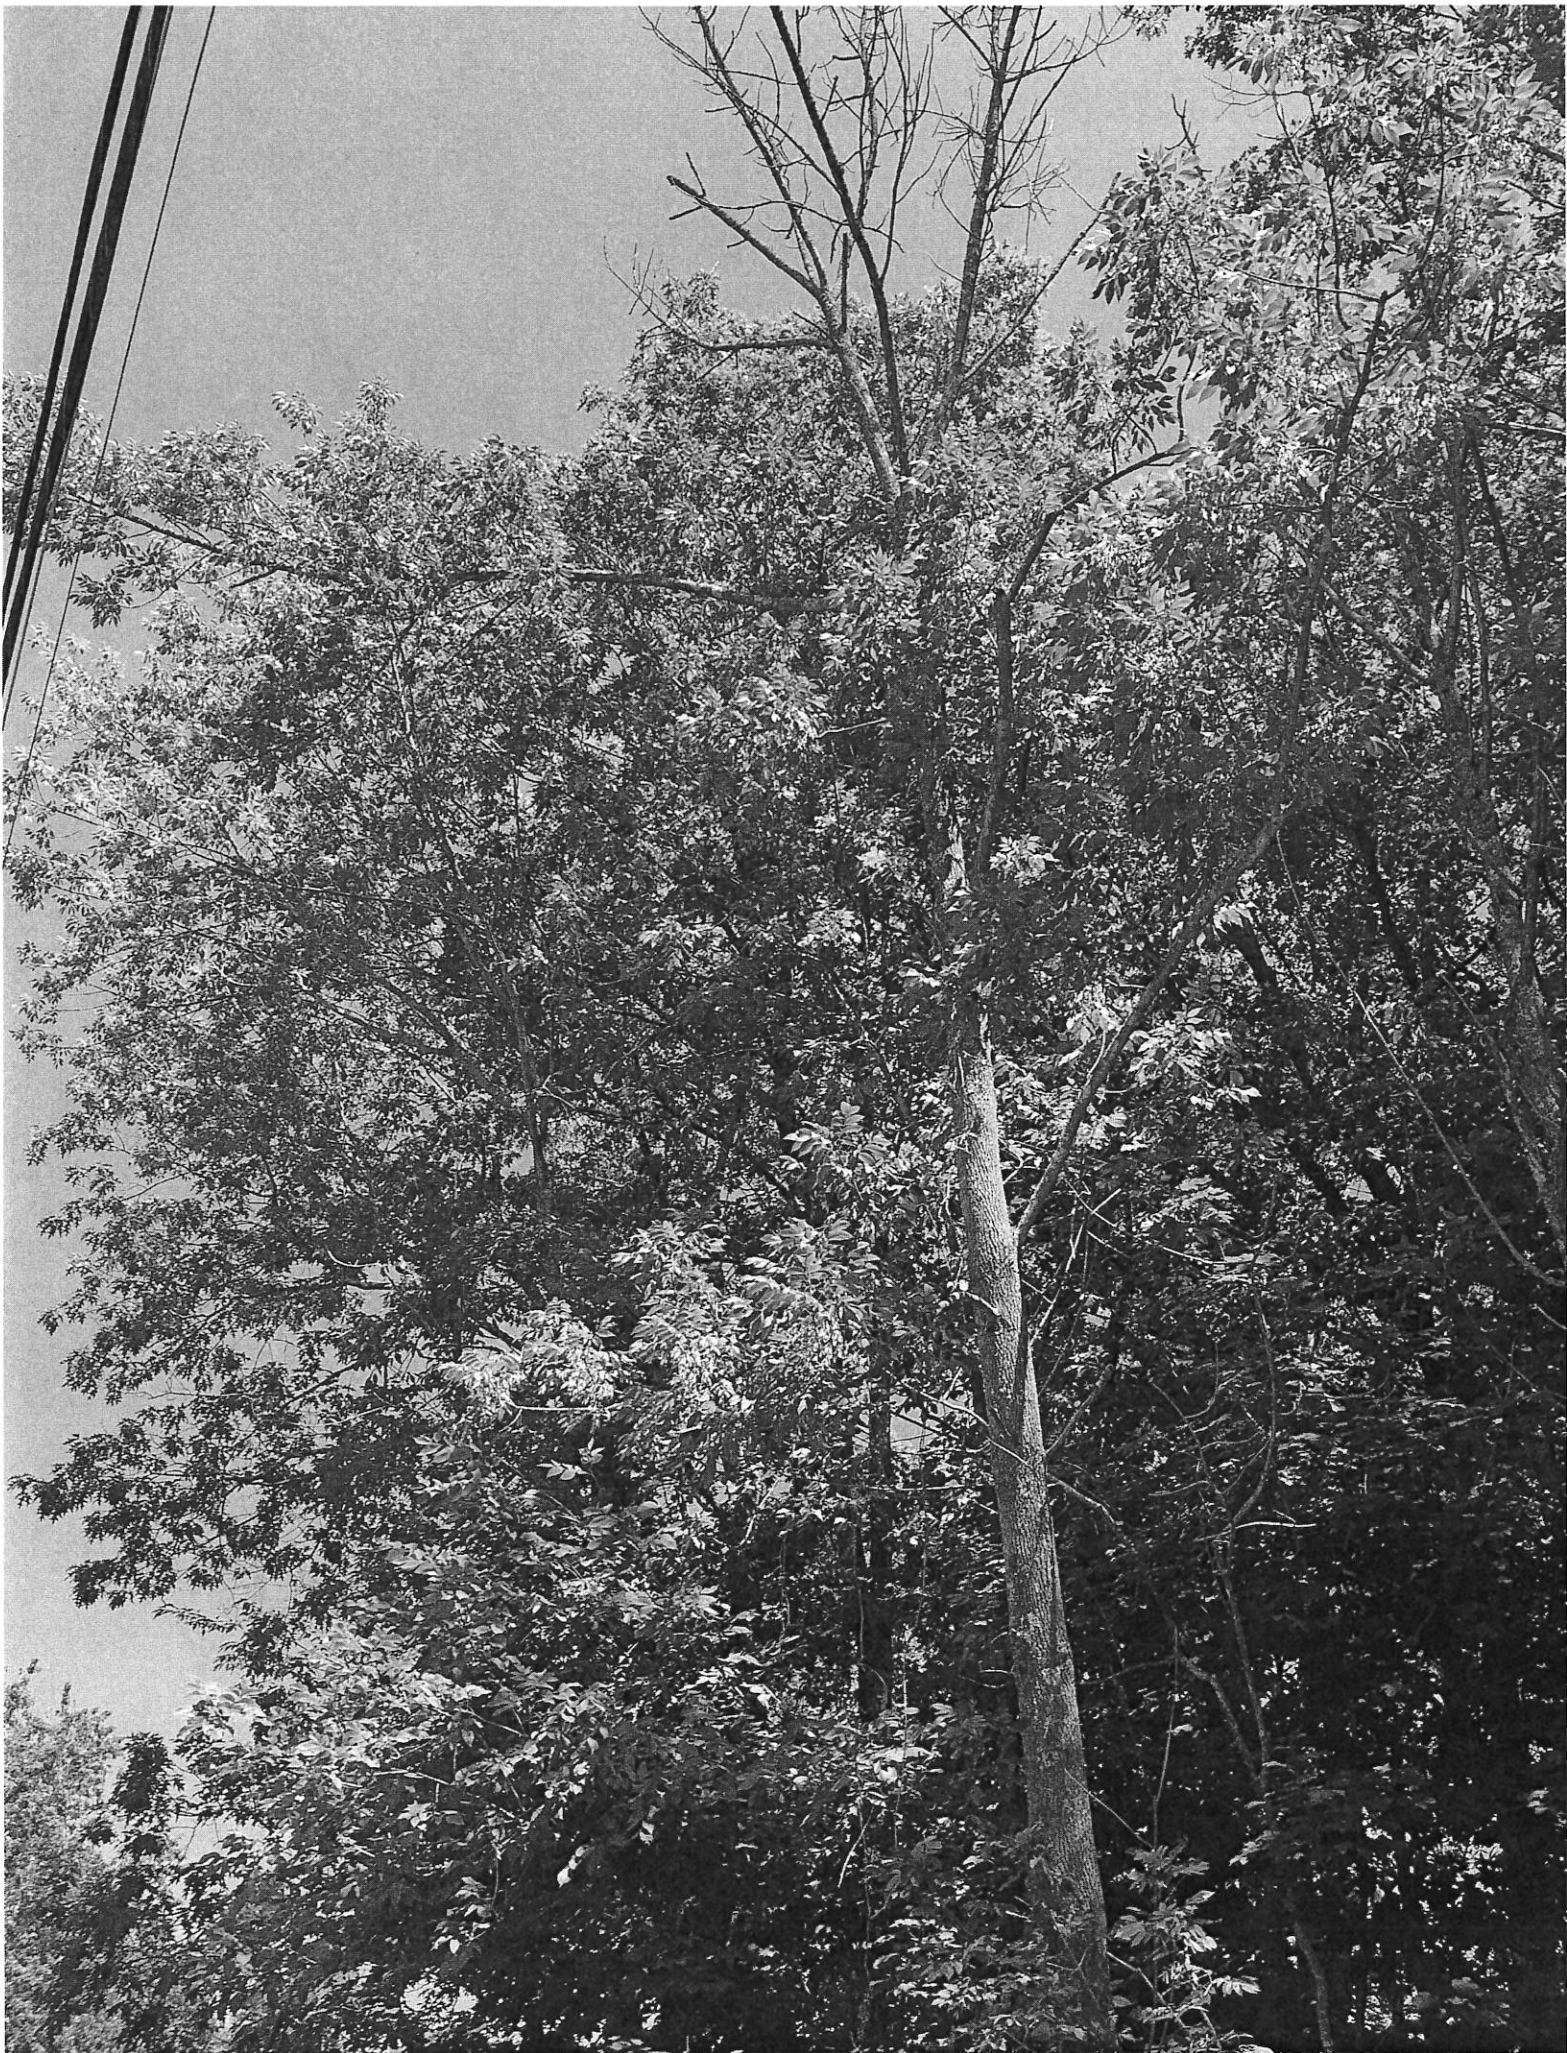
- Bob Berner notes that a number of the trees to be removed are ash trees. Unfortunately, many ash trees are now vulnerable to the emerald ash borer including some shown here.

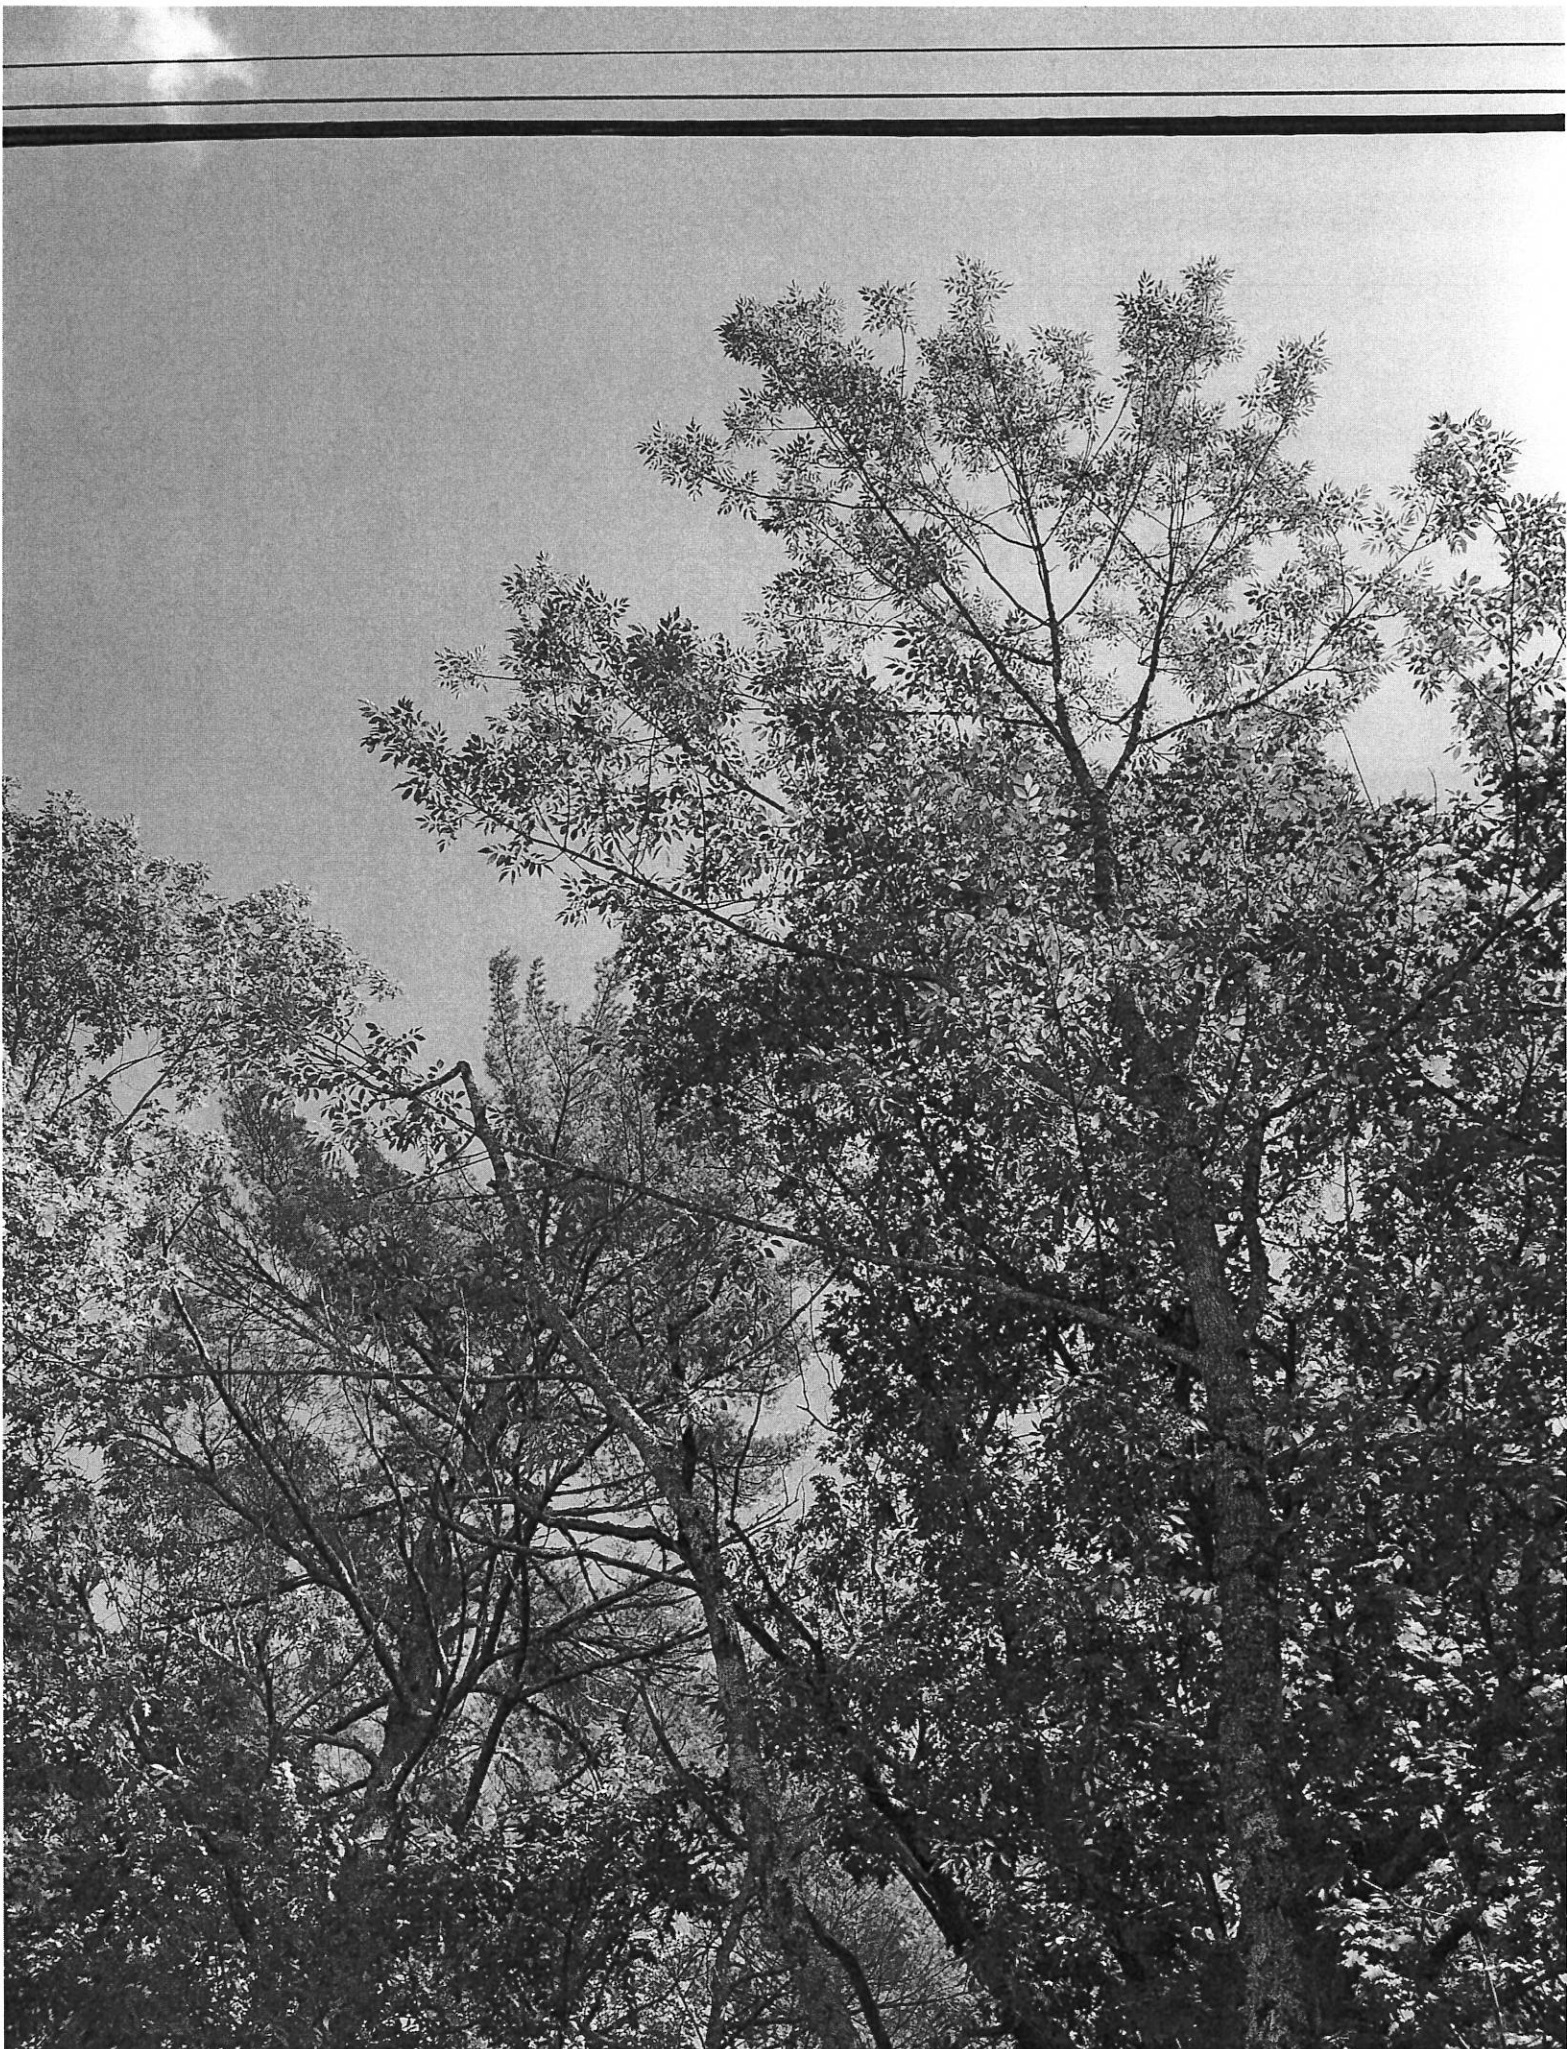
- Mike Lynch said that he did not see any concerns with removing the trees that are identified as they appear to be either dead or in failing condition such that there is a risk to the lines. He noted also that some branches are overhanging the road and could fall onto the road causing a hazard and blocking the road. Some of the trees have holes indicating insect infestation, weak branches, and seams indicating cavities in the middle. Mike stated that he believes Eversource is being surgical in its approach and selecting only those trees which are problematic.

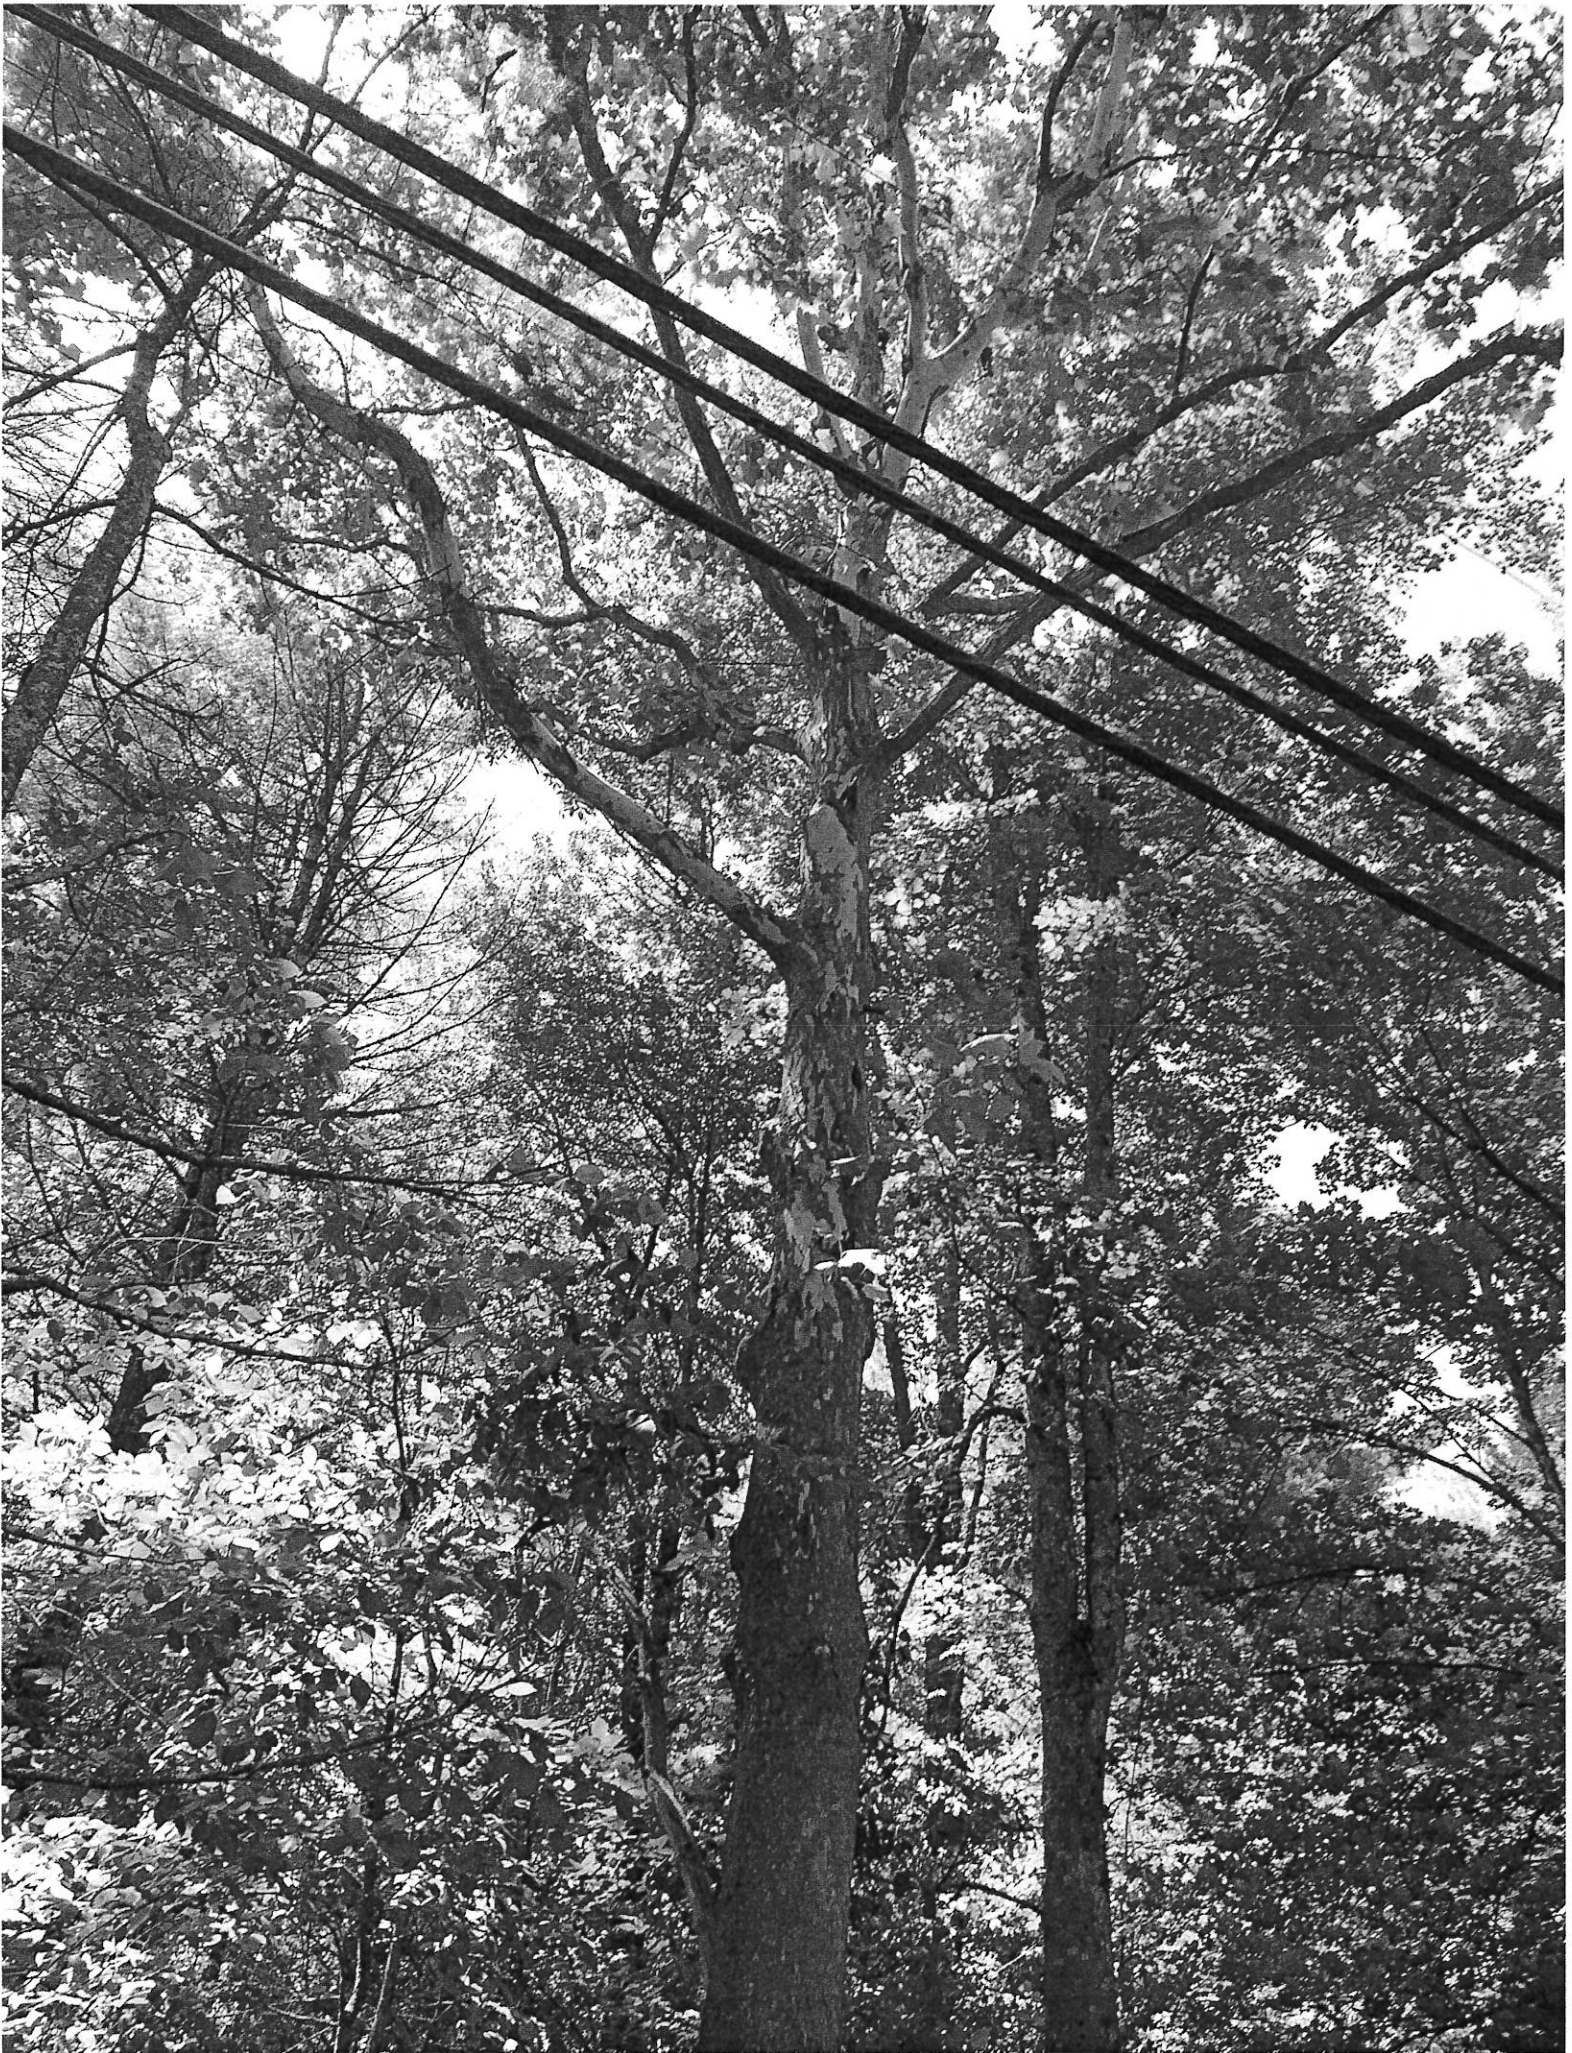
- Beth Olshansky expressed concern in an email about a sycamore tree on Packers Falls Road. I included a photo. There are several holes high up in the tree indicating cavities and possible insect infestation.
