College Brook Degradation & Flooding:

20 Years of Mill Plaza Violations* & Deceptions

Submitted to the Durham Planning Board, Conservation Commission, & Town Council, January 4, 2022

by Joshua Meyrowitz, 7 Chesley Drive, Durham, NH

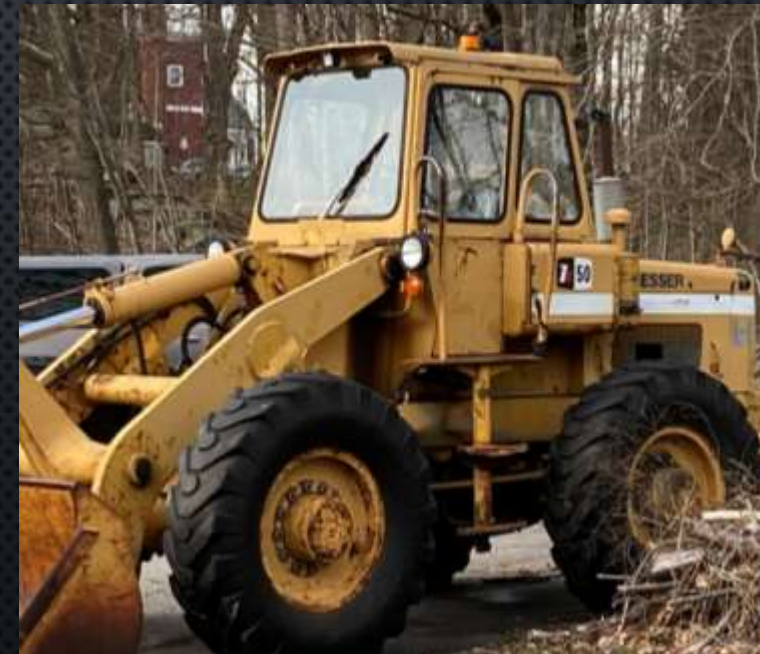
Mill Plaza Unauthorized Bulldozing of Hillside

- Sept. 2002: Mill Plaza manager Dave Garvey
 - Given permit to remove chain link fence & propane tank slab
 - **But bulldozed entire rear eastern hillside ~9,000sf (more cubic) (*without any Town or NHDES permits*)**
 - CDA plan: add 40 *rental* parking spots near site boundary at Chesley Marsh
- Residents trying to take photos threatened with arrest by CDA

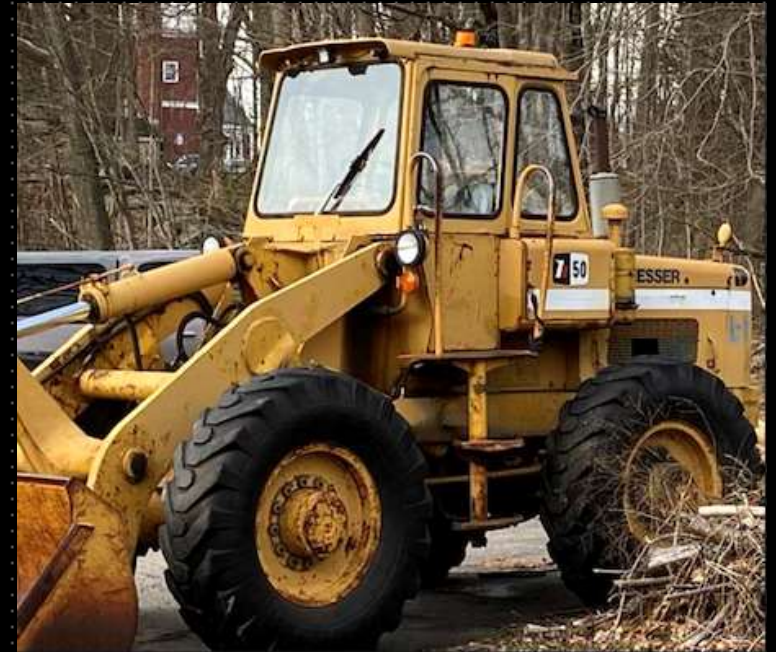
Results of Bulldozing Eastern Hillside

- Destruction of pleasant hillside, with rare-bird sightings
- **Added downstream silting & flooding ever since**
- Loss of sound/light buffer
- Residents had to pressure Town officials & Planning Board to intervene

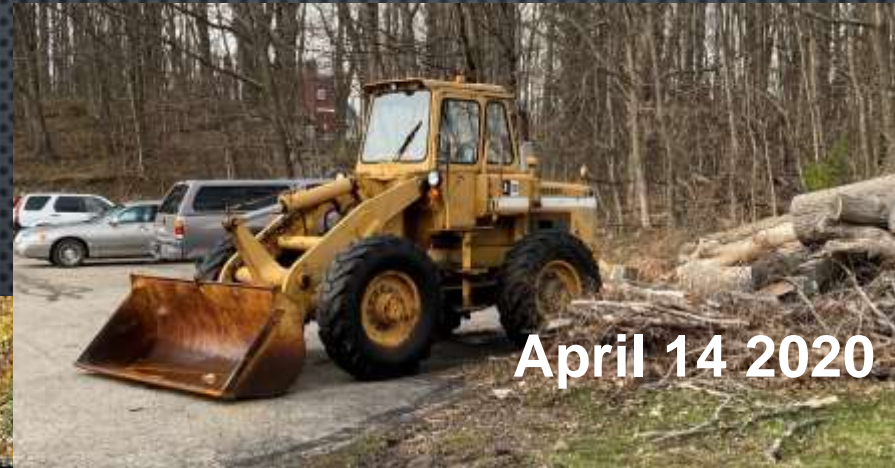
April 14 2020

Bad News: For 19+ years, CDA has ignored ban on parking in the bulldozed area, has not restored hillside – nor even maintained area.

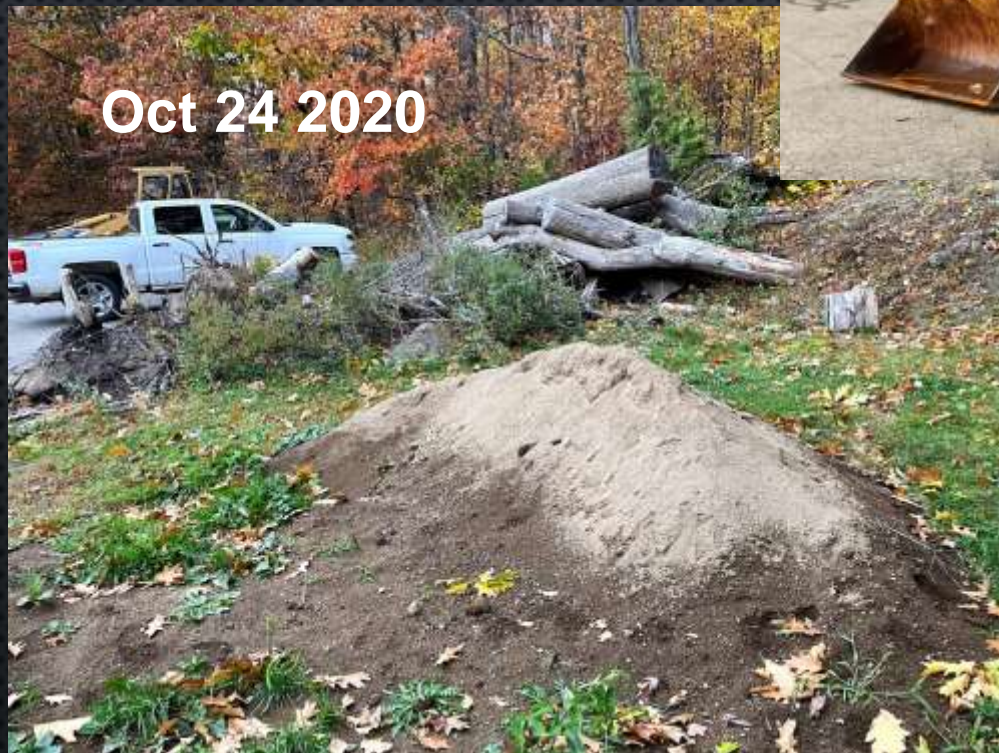
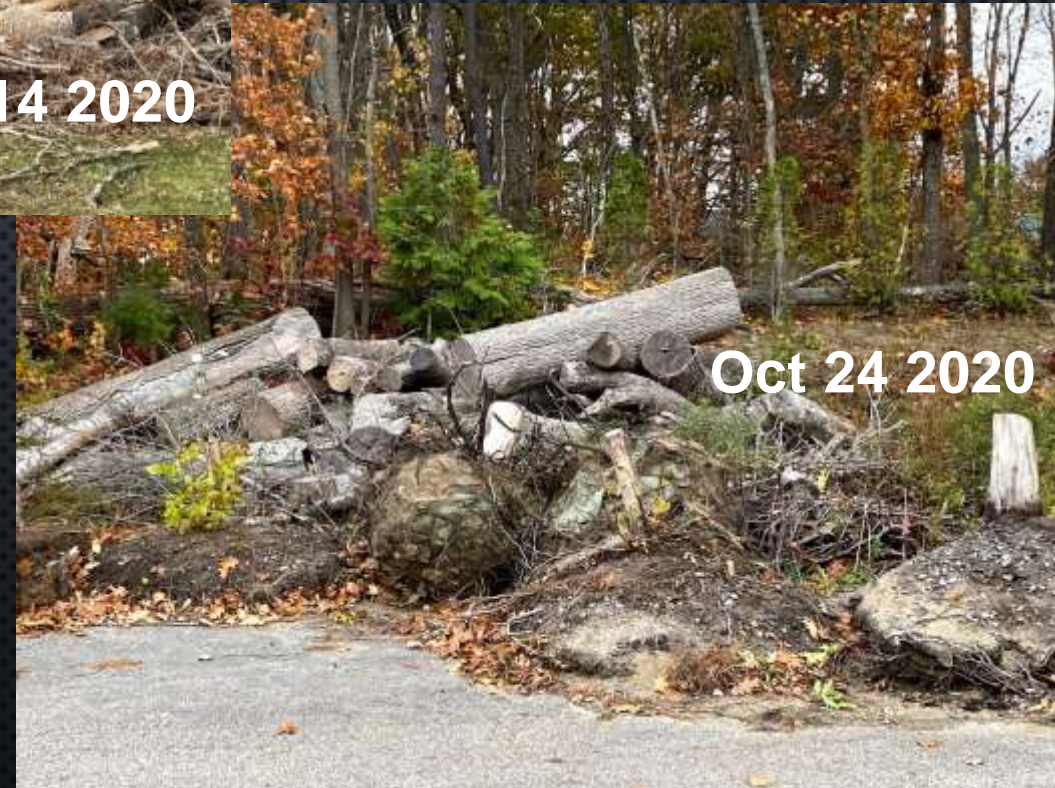
Oct 24 2020

**Town
has done
NOTHING!**
(about this)

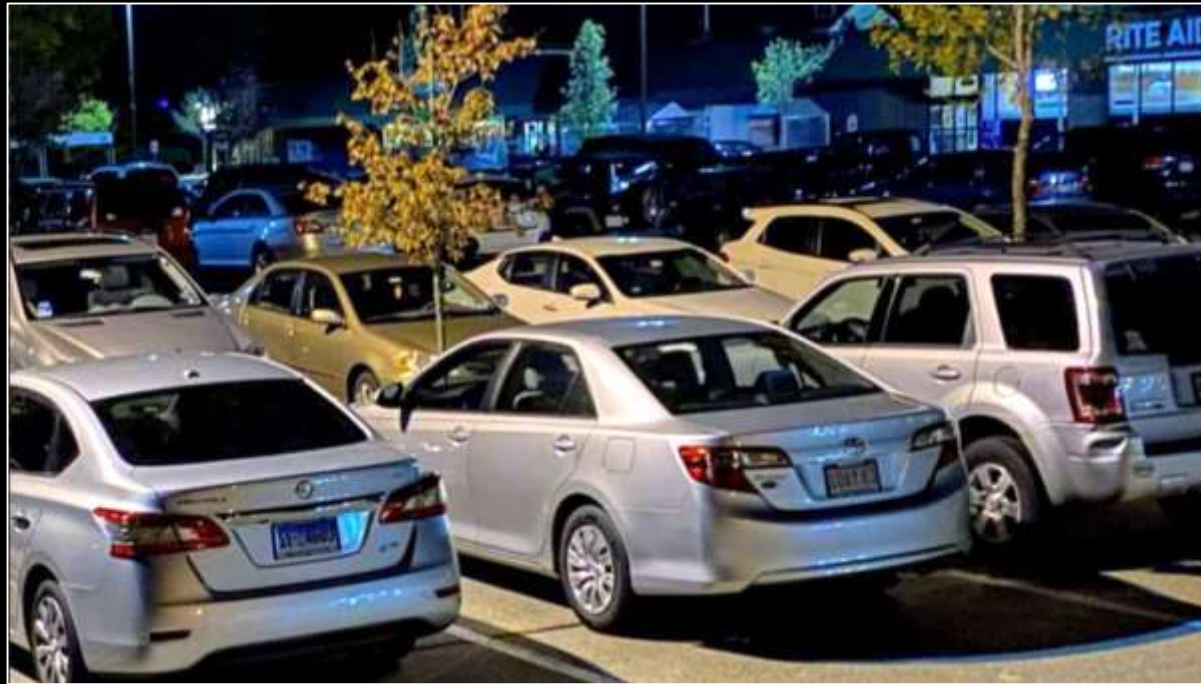
CDA has **EXPANDED** its unlicensed parking rental business to 150+ spaces.

Cars parked at
2:16 am, Wed
Sept 23, 2020

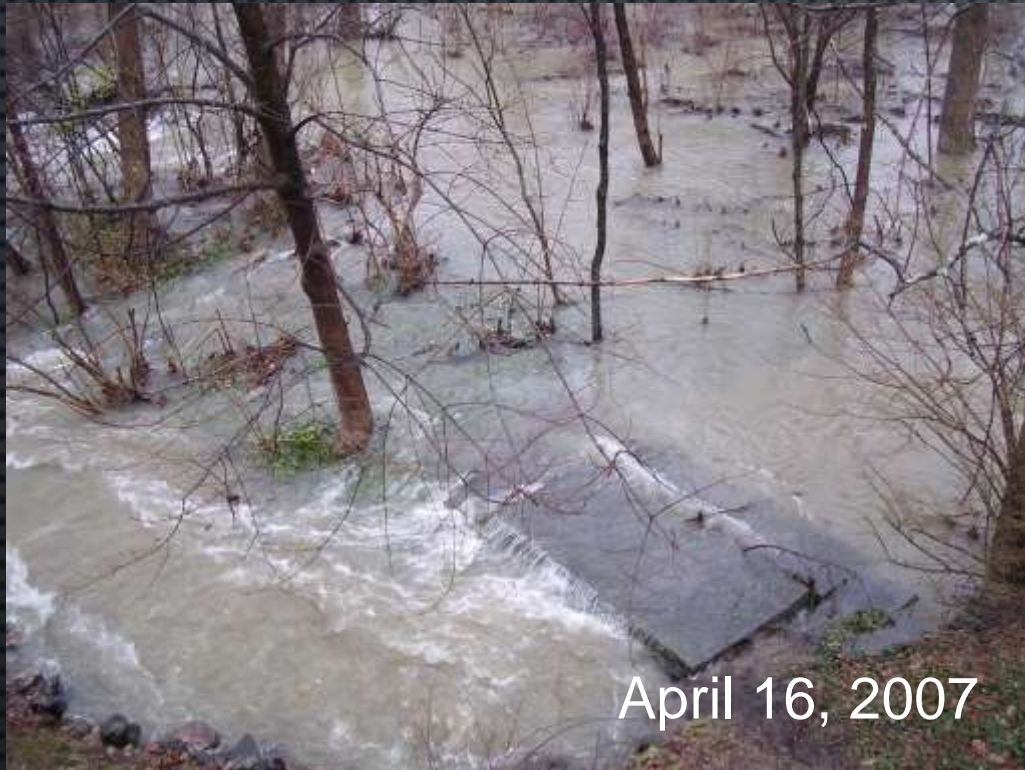
April 16, 2007

Views from
2nd floor
window,
7 Chesley Dr

Bad News: Increased flooding & property damage since 2002 NOT addressed

**\$1,000s of lost shrubs, trees,
perennials, top soil, whole gardens**

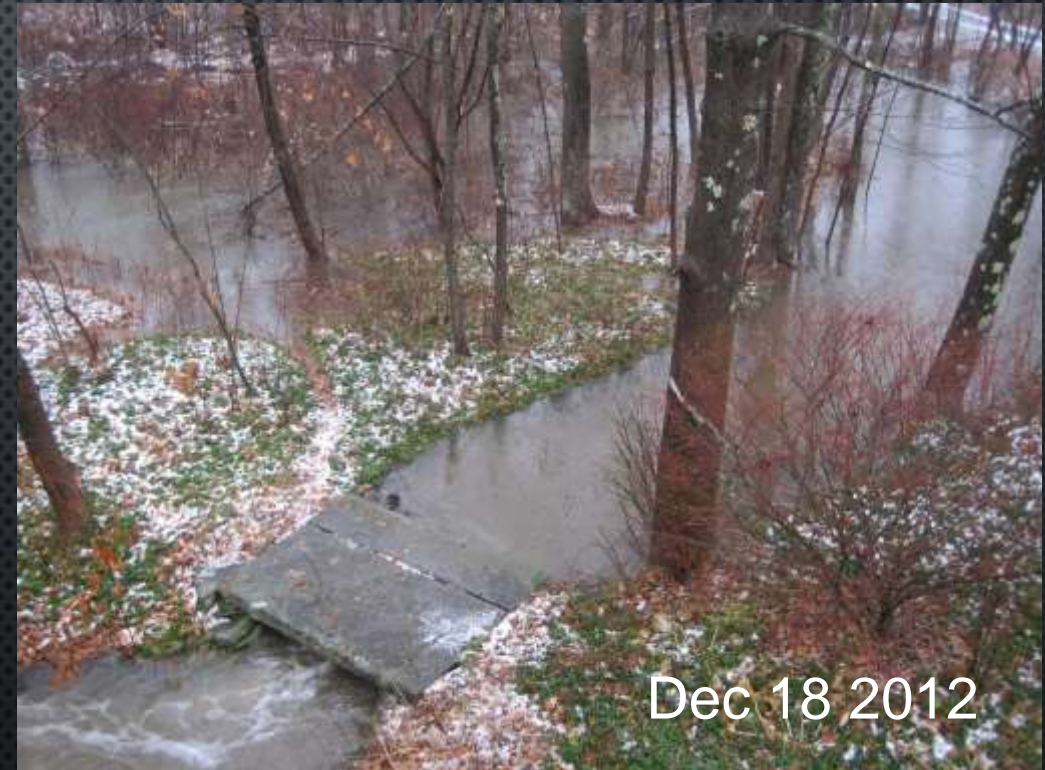
**← 2nd Brook channel
from flooding erosion**

**Roots
Exposed →**

←← Brook bank pre-2002

**7 Chesley Dr
April 15, 2020**

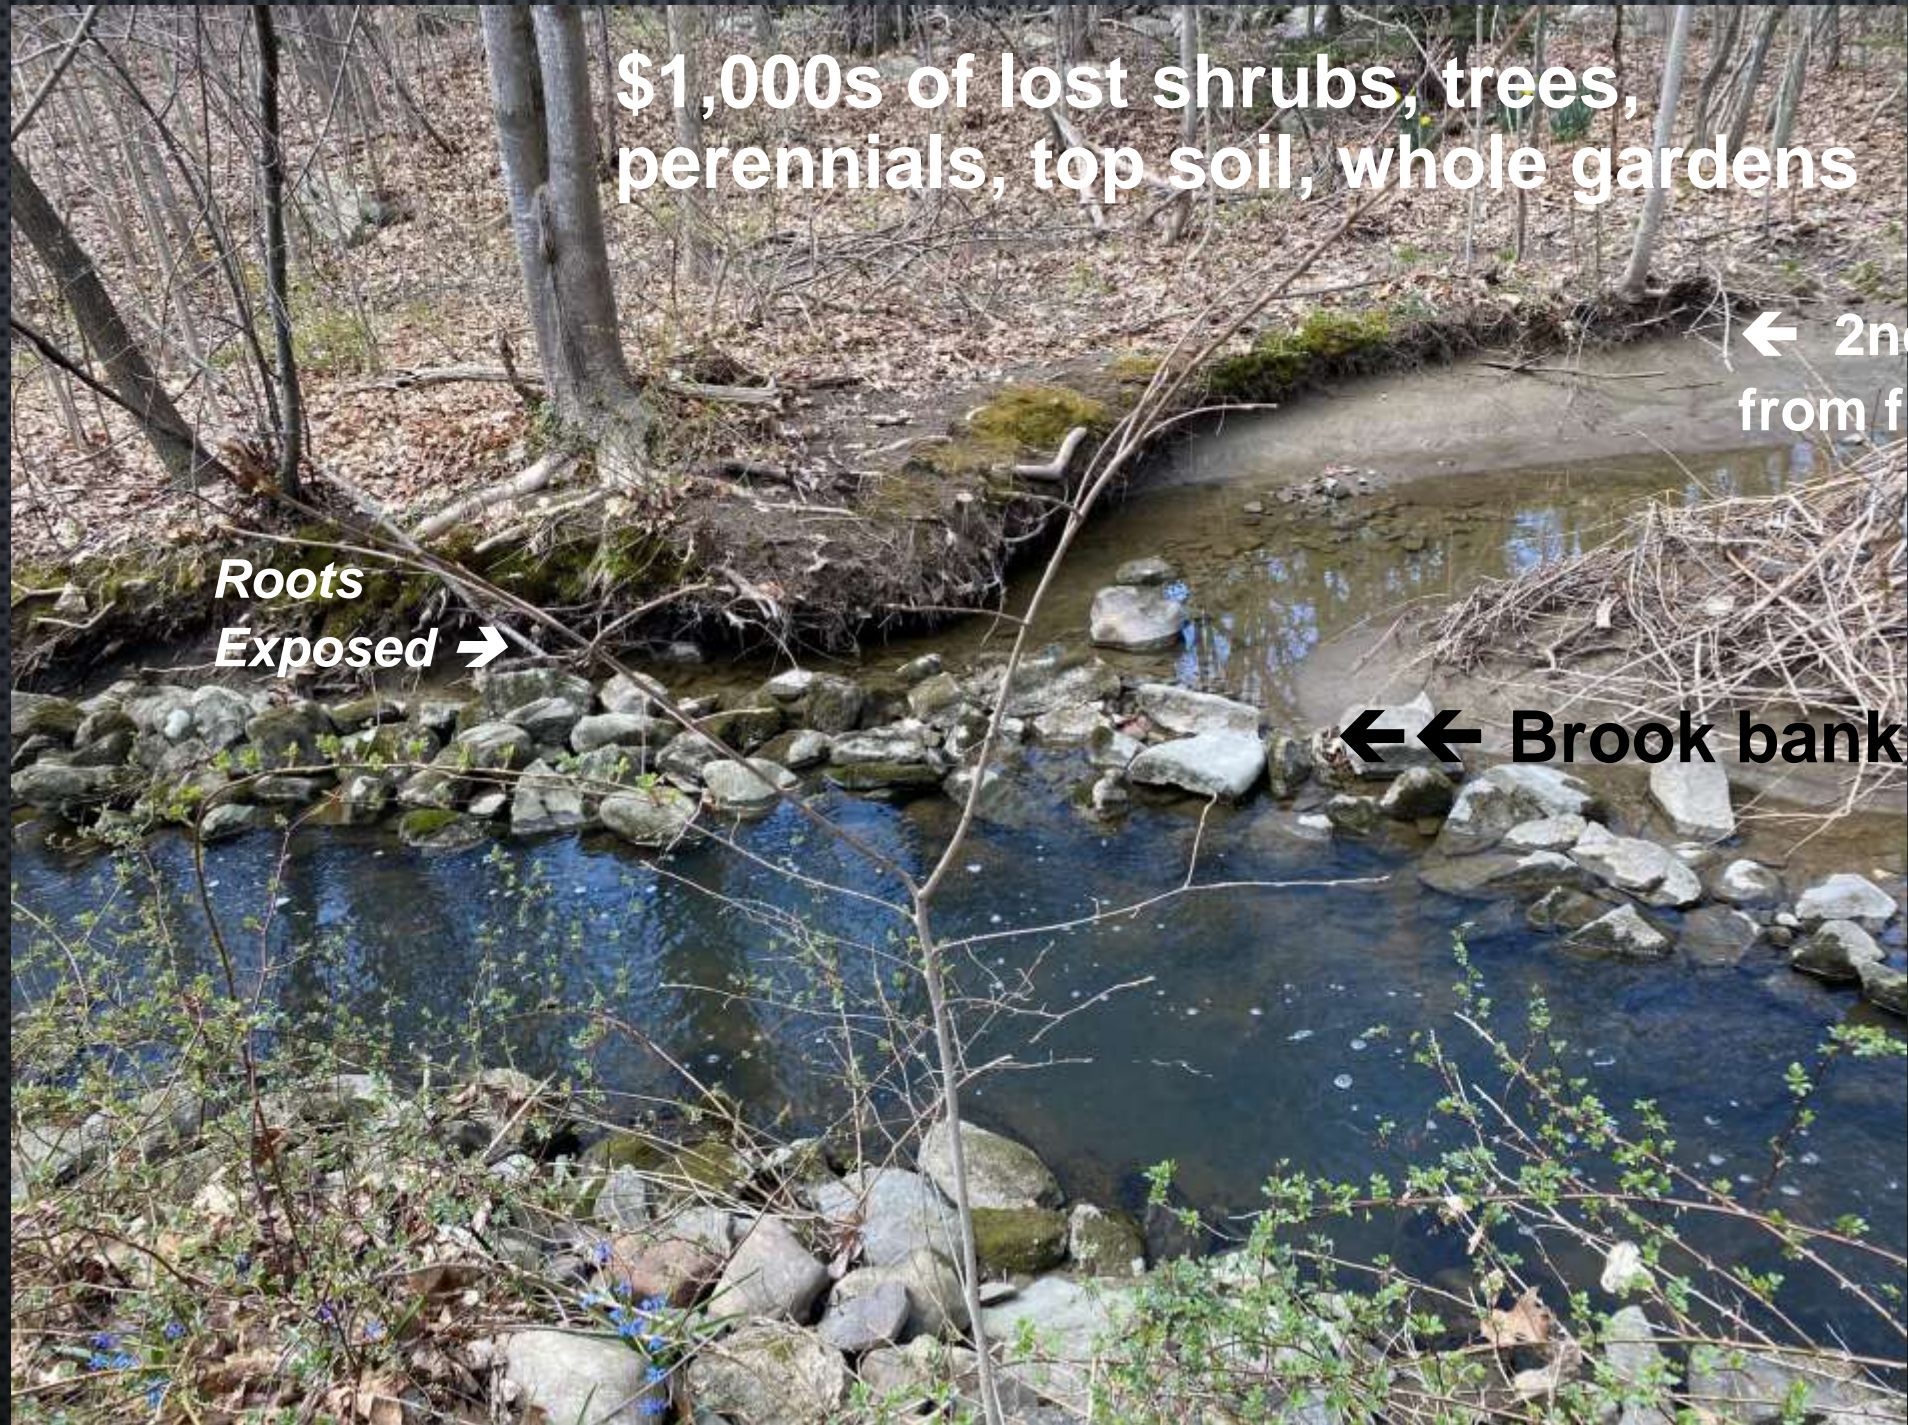
December 2015 — CDA signs Legal Agreement pledging restored 75-ft wetland buffer *increased pervious ground would reduce downstream flooding*

CLAUSE 1d “The Revised Application will provide for proposed buildings and vehicular roads outside of the shoreland and wetland buffers such that variances from town ordinances are not required and the buffers are maintained by the property owner.” – Dec 14, 2015, Legal Settlement [[background/highlights](#); [full agreement](#)].

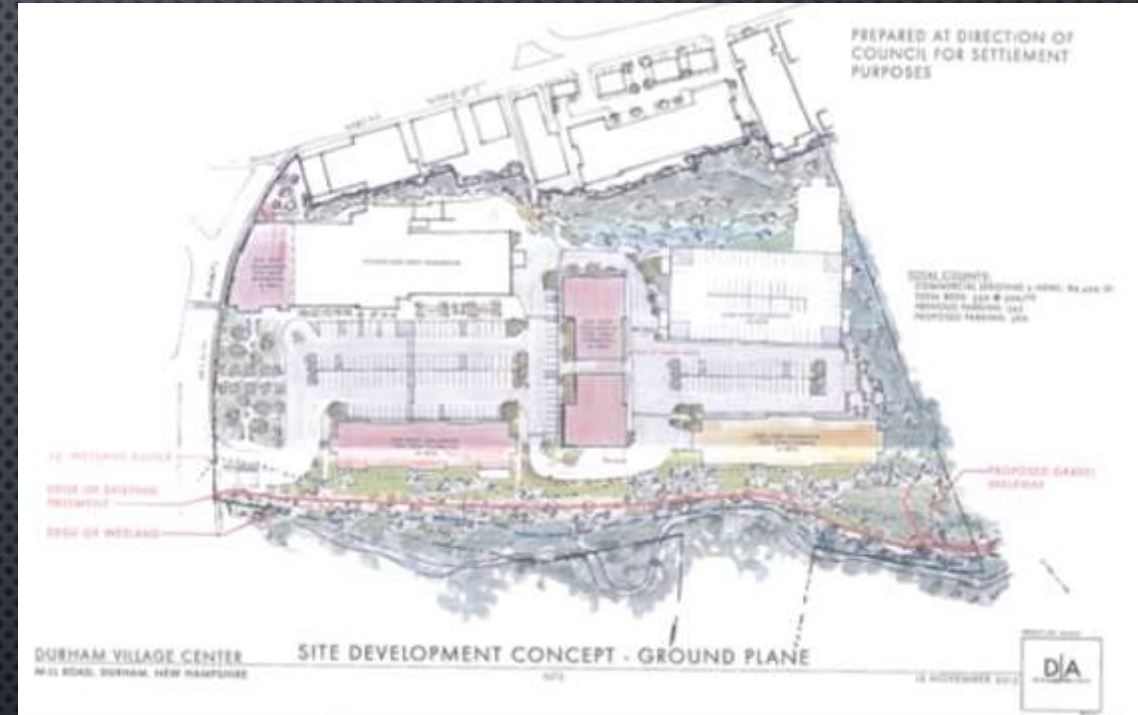
Conceptual Design in Settlement:
buildings & roads outside of buffer

No plan submitted by CDA to date complies with this clause of the Legal Agreement

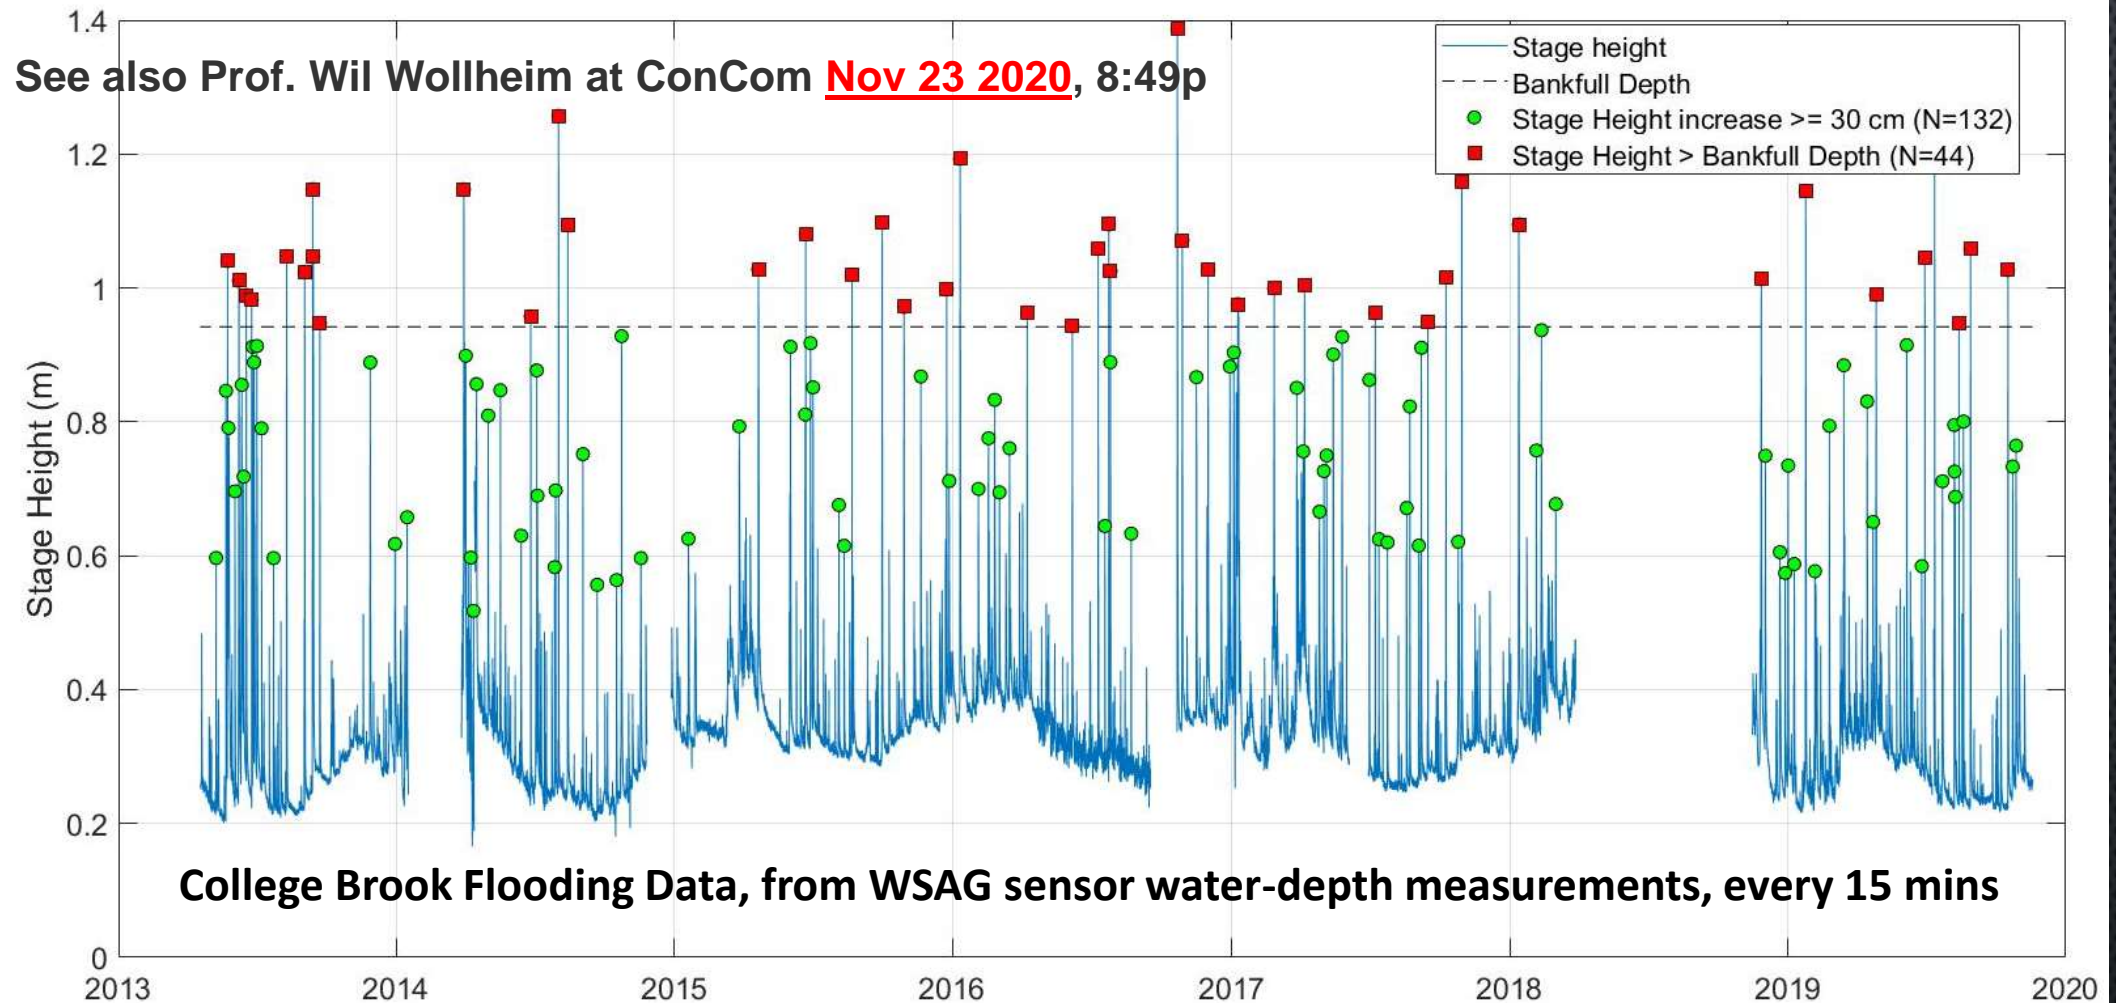
UNH Water Systems Analysis Group (WSAG)

WSAG sensor data: April 2013 to Nov 2019, 132 storm events with stage-height rise of 12" or more (1.7/mo avg), 44 exceeding "bankfull depth" (.6/mo avg).

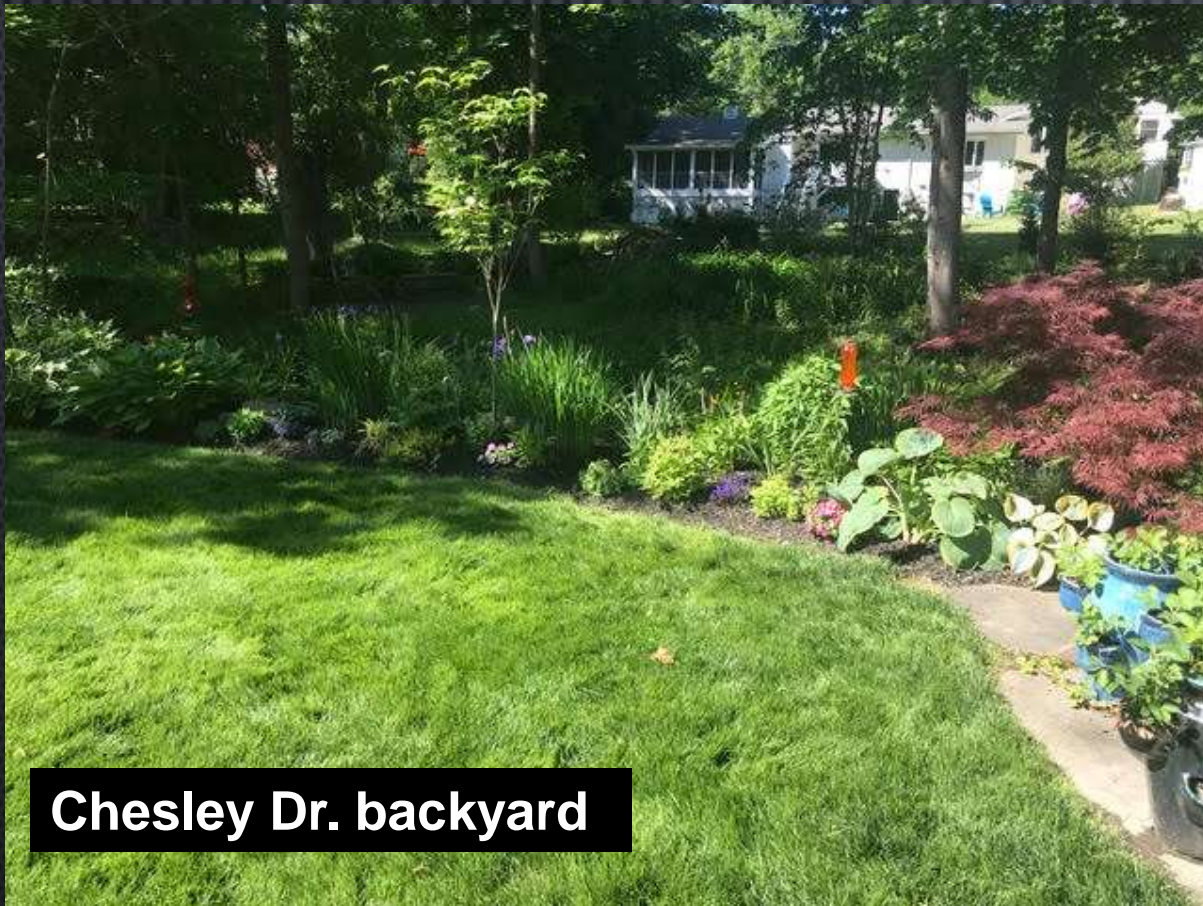
Chesley Dr. backyard

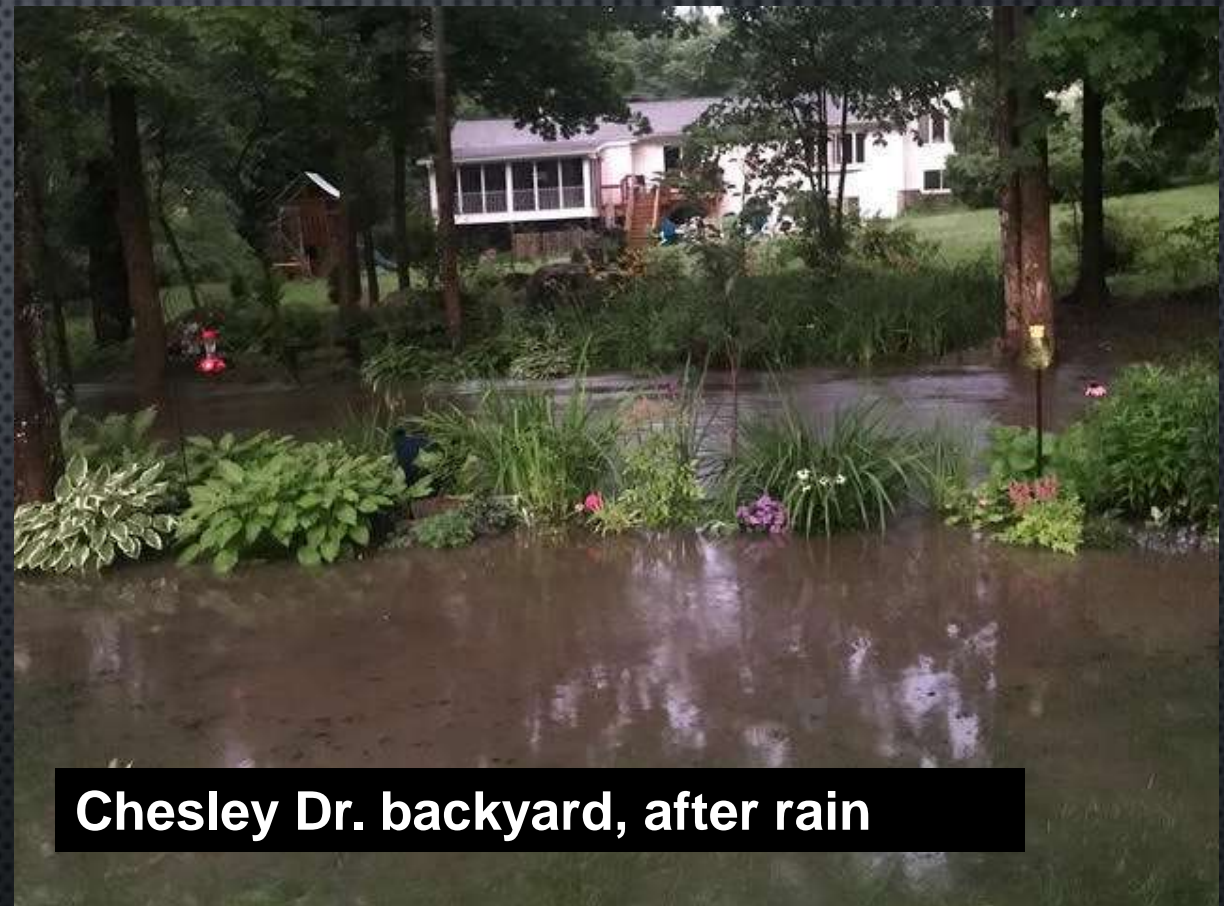
Chesley Dr. backyard, after rain

“The flooding is a major concern. In the short 6 months we have lived at 5 Chesley, we have noticed a lot of flooding and standing water on our property. It makes it difficult to mow regularly and disrupts the peaceful enjoyment of our property.” – *New owners’ comment, 1-3-22*

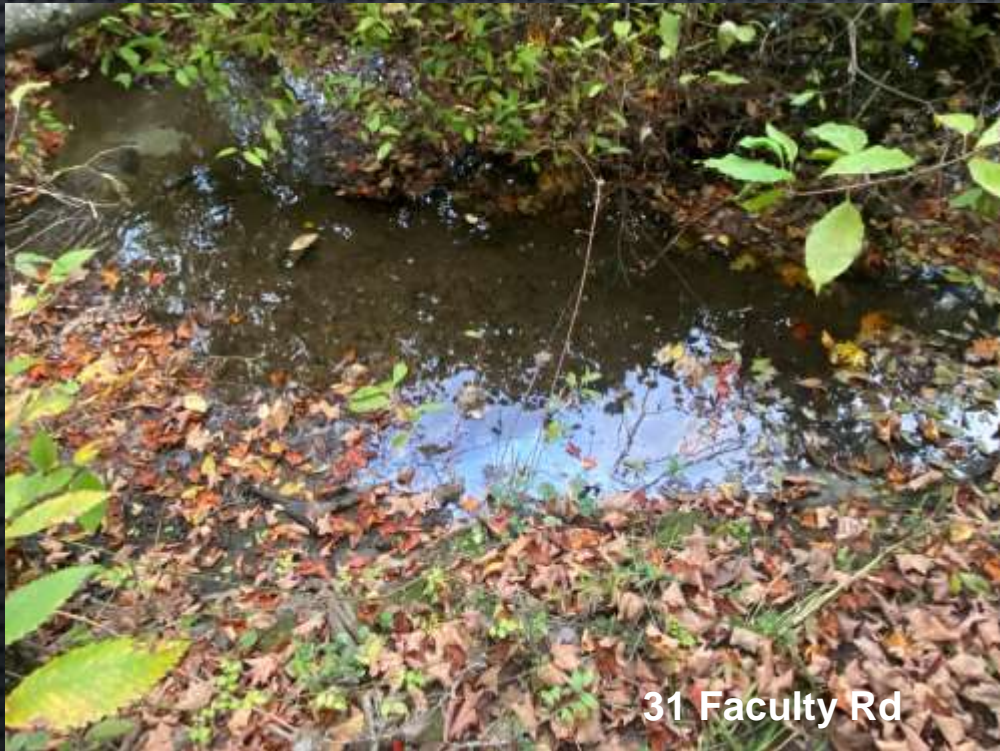
Dr. Eric Lund at 31 Faculty Rd, downstream of the Plaza, reports that when he bought his house in 1998, he owned dry land across the Brook, and there was a bridge to reach it (so that it could be mowed).

After the unauthorized CDA bulldozing of the eastern Plaza hillside in 2002 – which led to noticeably increased flooding on downstream properties – both his bridge and the land the bridge reached washed away from the increased College Brook flooding.

Dr. Lund adds that there was a period of time when he could see a flap of sod (the soil underneath it having been washed away), but that's now long gone as well.

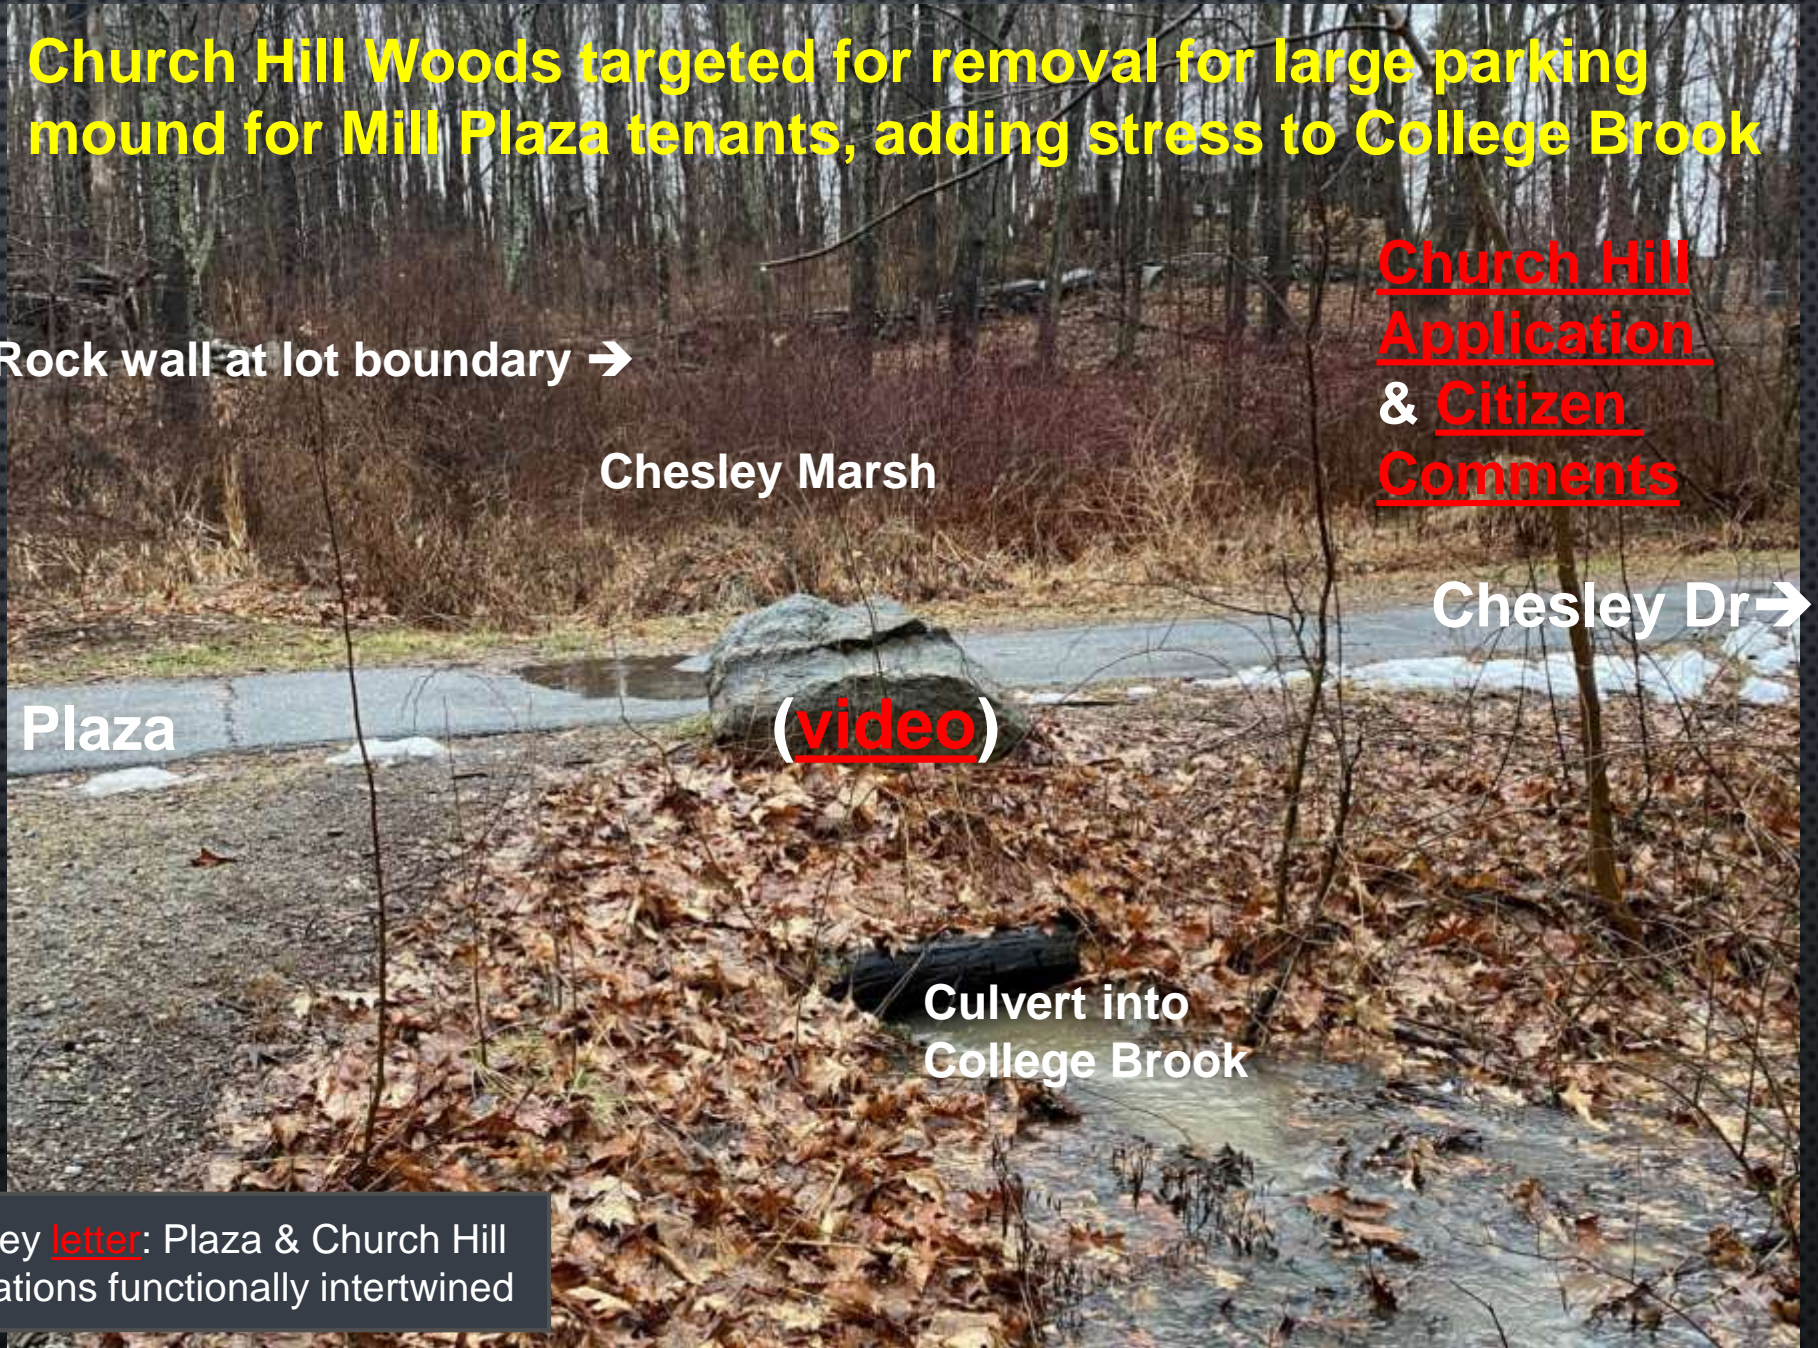
Church Hill Woods targeted for removal for large parking mound for Mill Plaza tenants, adding stress to College Brook

Chesley Marsh & College Brook flood zone would function as parking structure's stormwater "drains."

A wide diameter drainage pipe at base of parking mound would direct stormwater toward wetland & impaired College Brook.

Rock wall at lot boundary →

Chesley Marsh

Culvert into College Brook

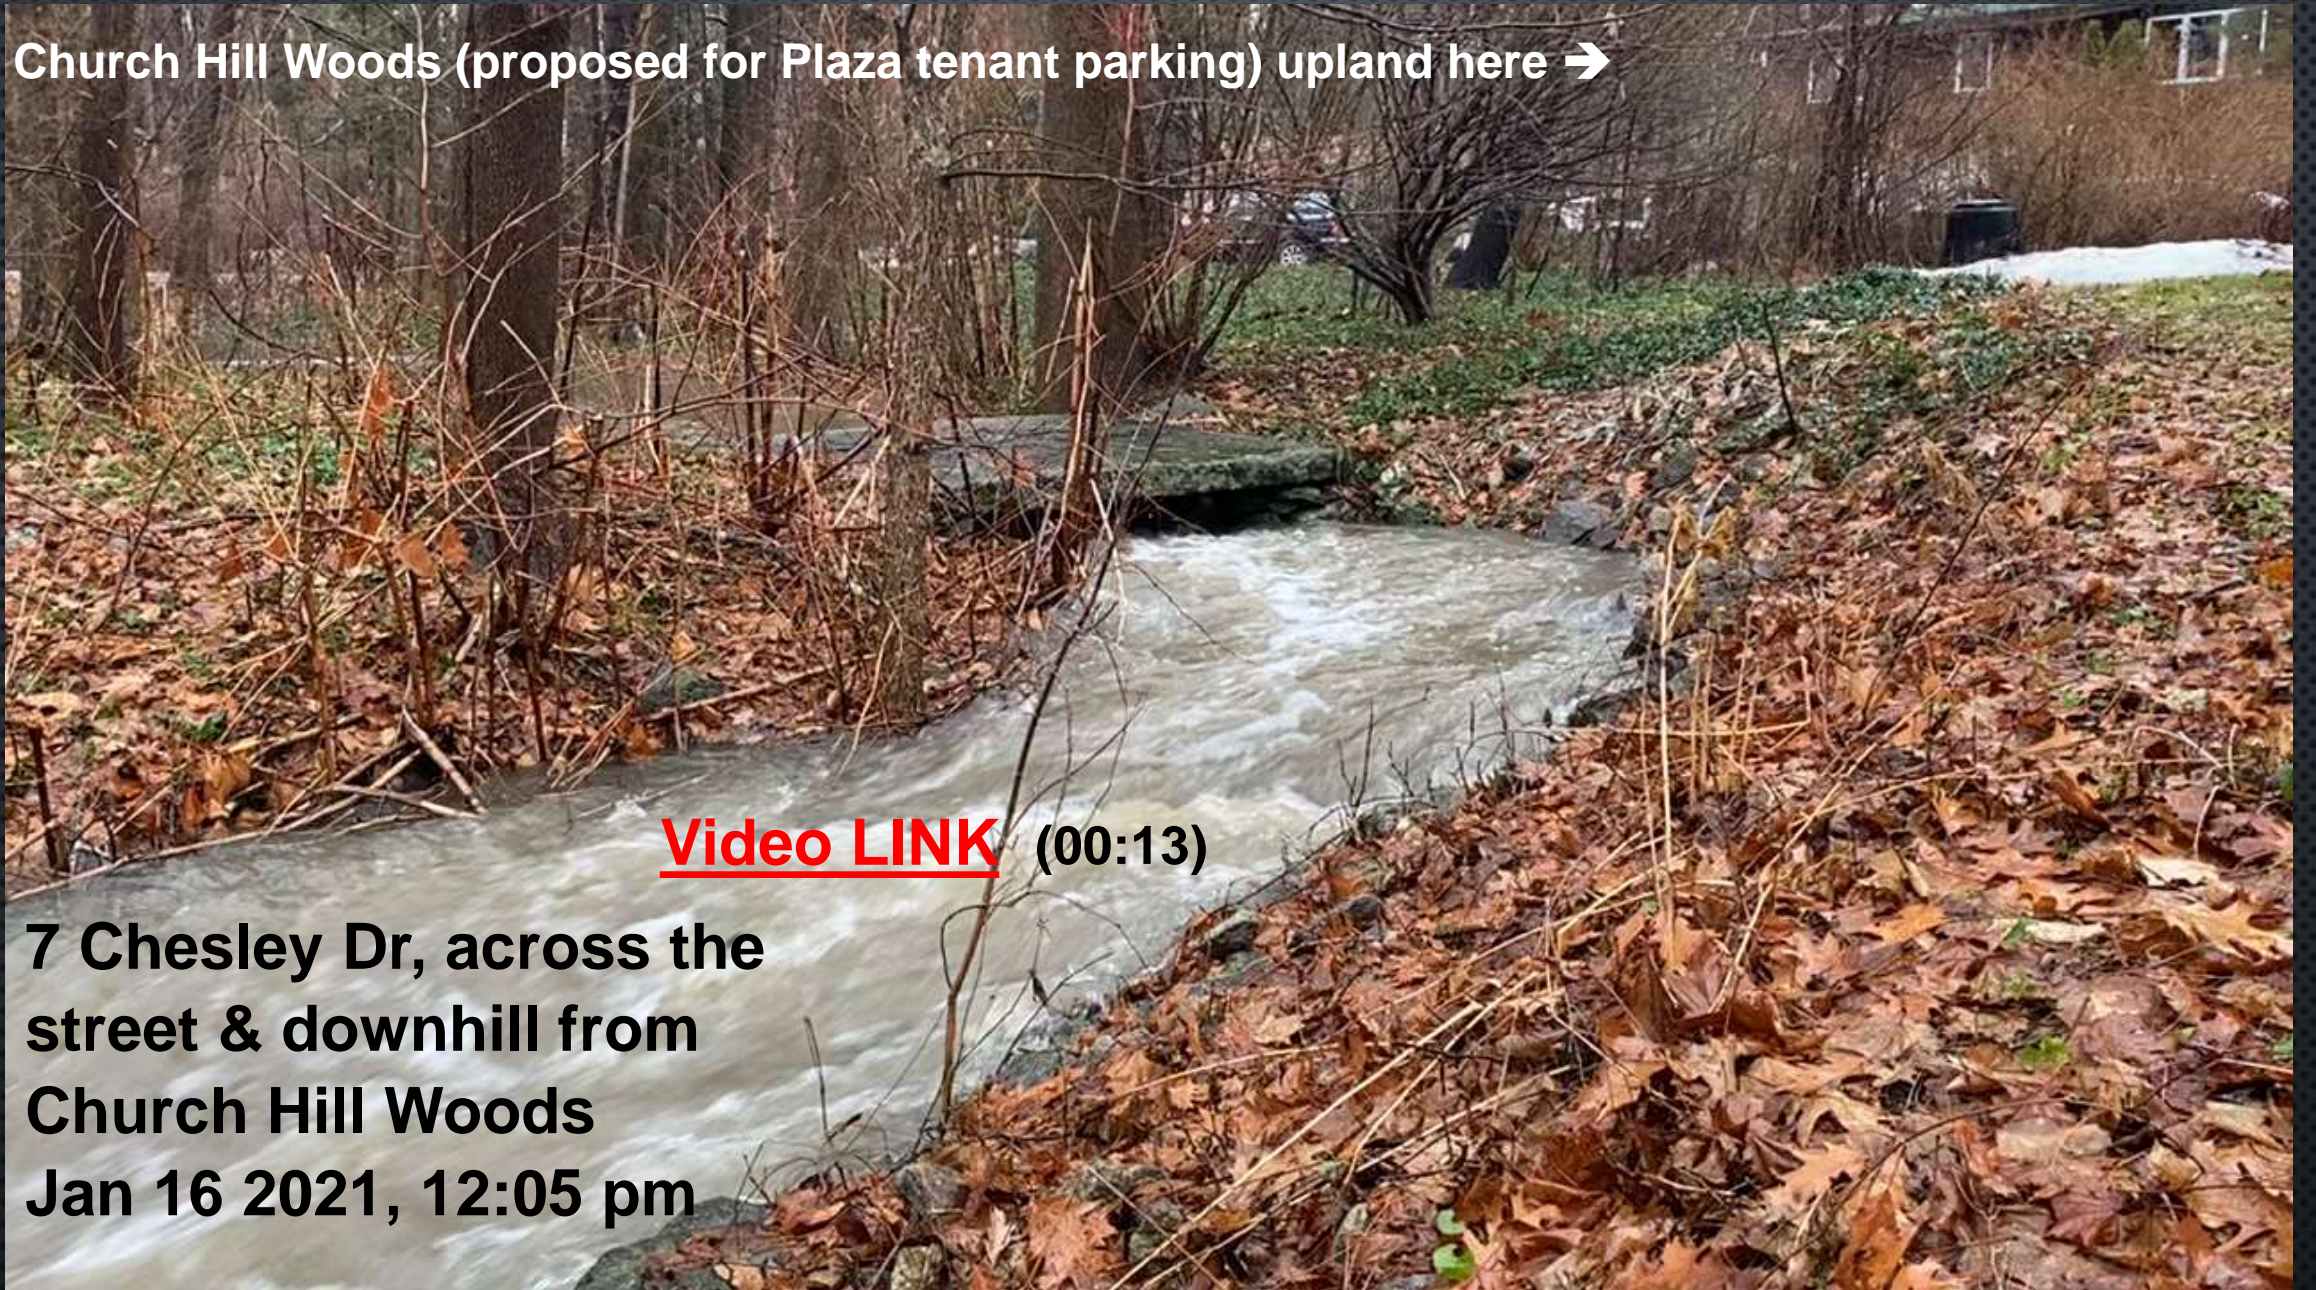
Church Hill Woods (proposed for Plaza tenant parking) upland here →

7 Chesley Dr, across the
street & downhill from
Church Hill Woods
Jan 16 2021, 12:05 pm

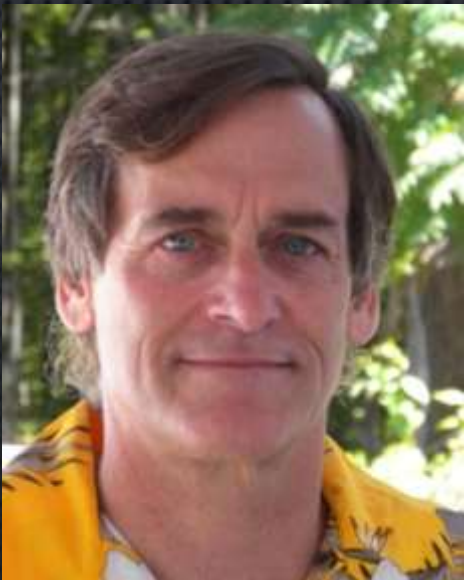
**Dir., UNH Stormwater Ctr
& Streamworks Consulting**

Without greater reduction in stormwater VOLUME from within the Plaza site, the slower release from Plaza likely to increase downstream flooding.

As CDA’s “Streamworks” Consultant, Professor Thomas Ballestero explained to the Planning Board on [Jan 27, 2021](#), with the *delayed* release of water from the Plaza site with the improved stormwater system, flooding downstream might actually *increase*, because Plaza water would then join the later flow from upstream.

“Today, when it rains, it hits the asphalt [in Mill Plaza], gets to the Brook, and runs out to the Oyster River very quickly. While all the other runoff from upstream is coming downstream [later]. In the future, you are going to be holding that [Mill Plaza] runoff and then slowly releasing it at the same time the water is coming from upstream [leading to an increase in downstream flooding].” – *Prof. Ballestero at 10:17:12 pm, Jan 27, 2021*

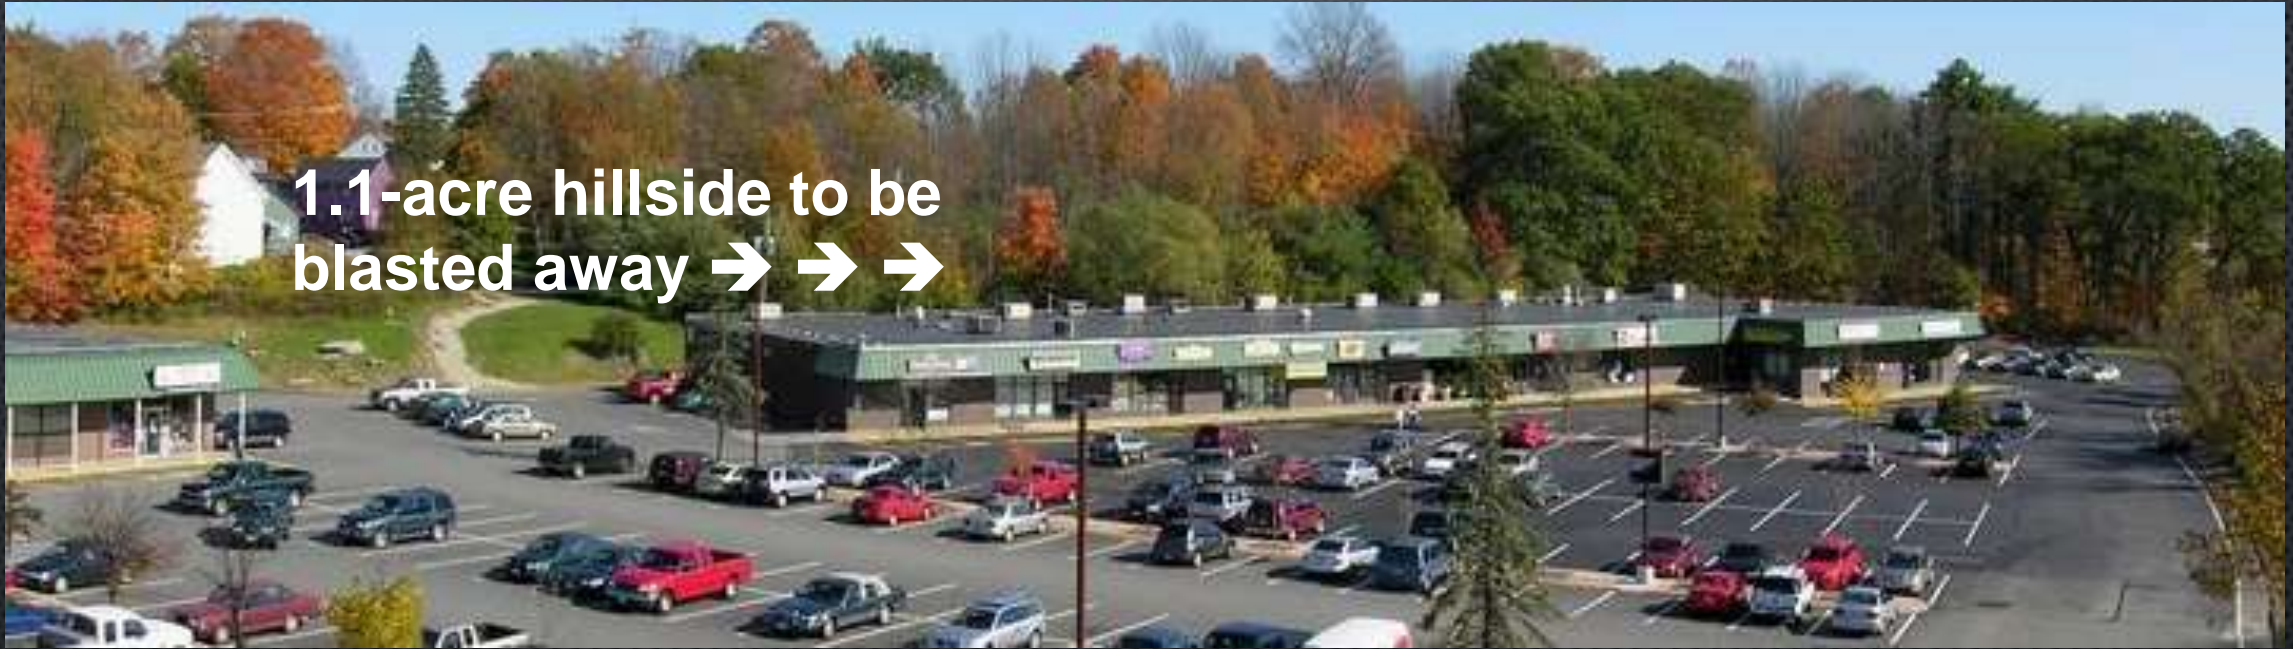
Plaza hillside is a “granite knoll,” a “ledge outcropping,” “not gonna really absorb water” as typical soil would – CDA Engineer Joe Persechino, [10-26-20](#)

1.1-acre hillside to be
blasted away → → →

CDA claims that removing a thickly vegetated hillside would NOT stress stormwater system or negatively affect wetland, brook, & watershed nor violate [CU zoning](#) restrictions (“Shall not degrade...mature tree lines...viewsheds.”)
