College Brook Degradation & Flooding:

20 Years of Mill Plaza Violations* & Deceptions

Submitted to the Durham Planning Board, Conservation Commission, & Town Council, January 4, 2022

by Joshua Meyrowitz, 7 Chesley Drive, Durham, NH

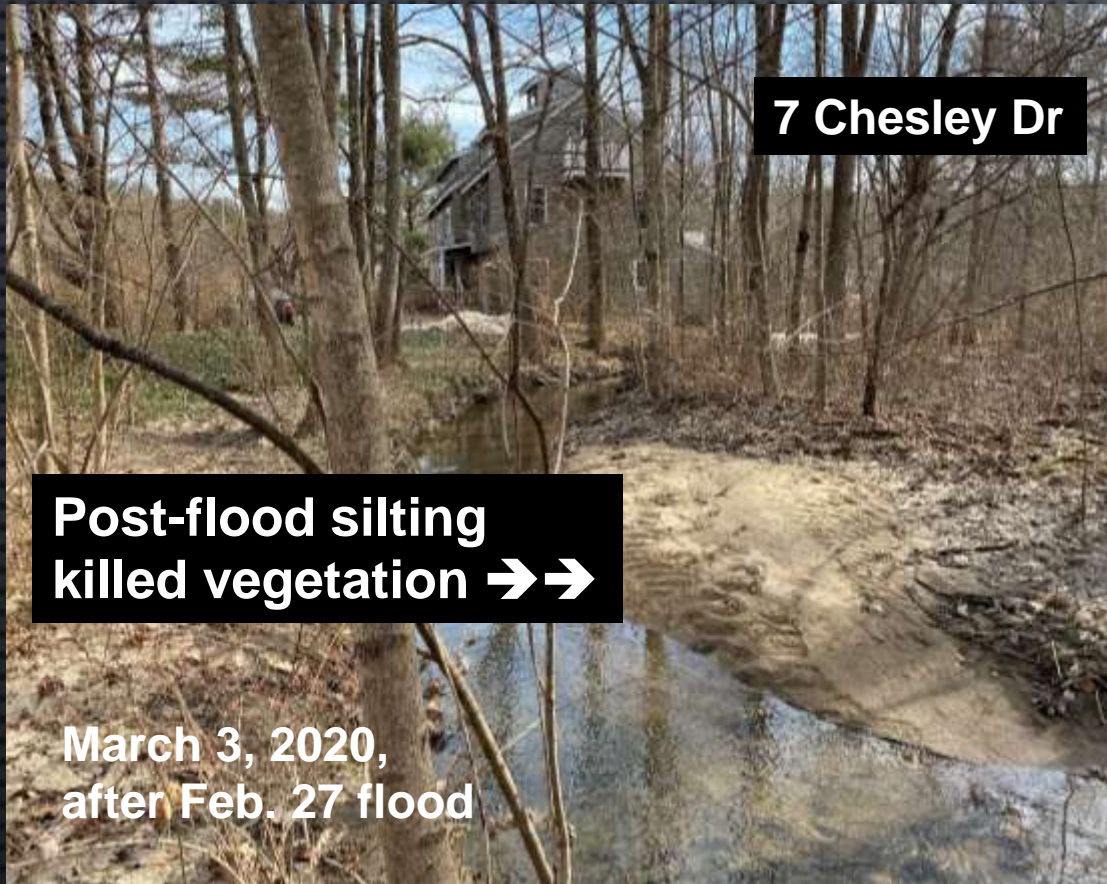
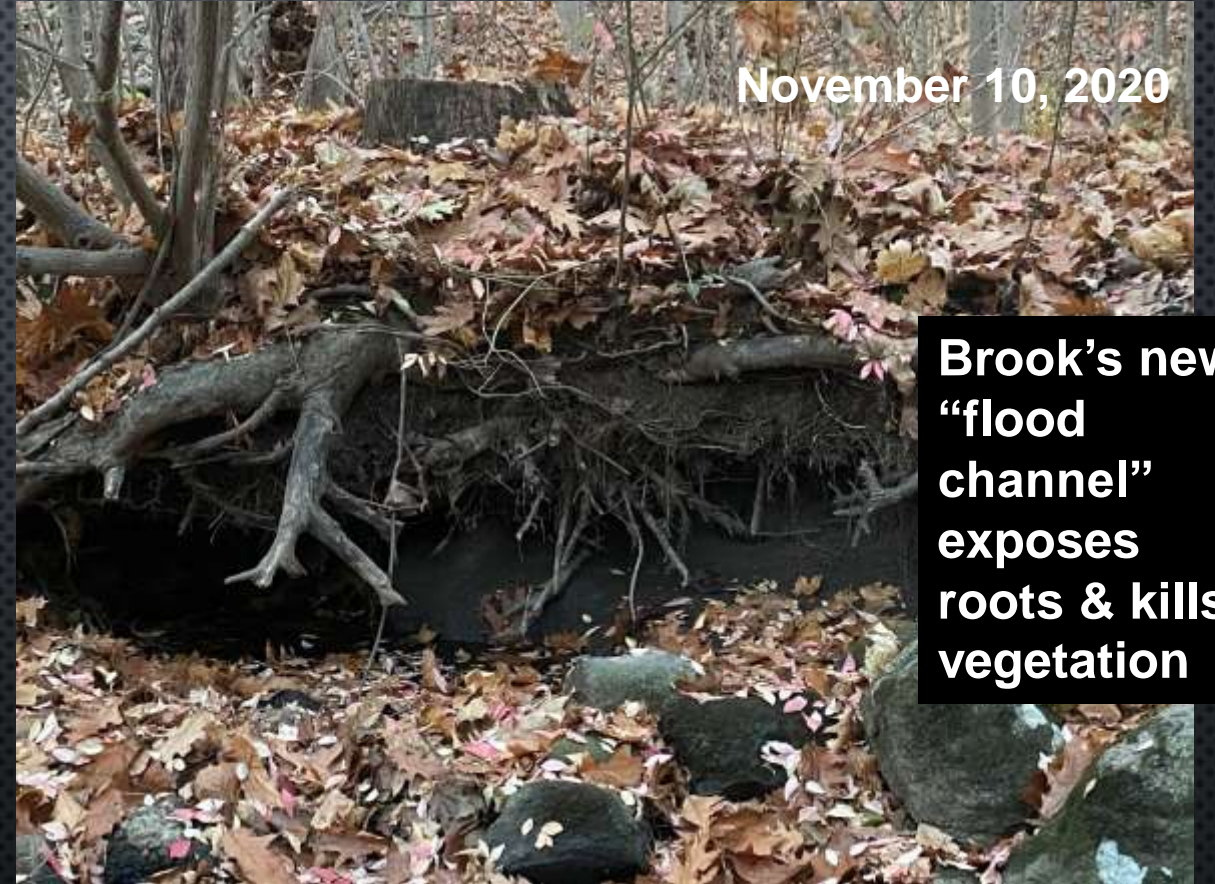
Plaza hillside destruction would likely max out new stormwater plan – with NO commitment to improve ONGOING flooding/erosion that increased after 2002 eastern hillside bulldozing.

The Town of Durham is implicated in downstream flooding damage.

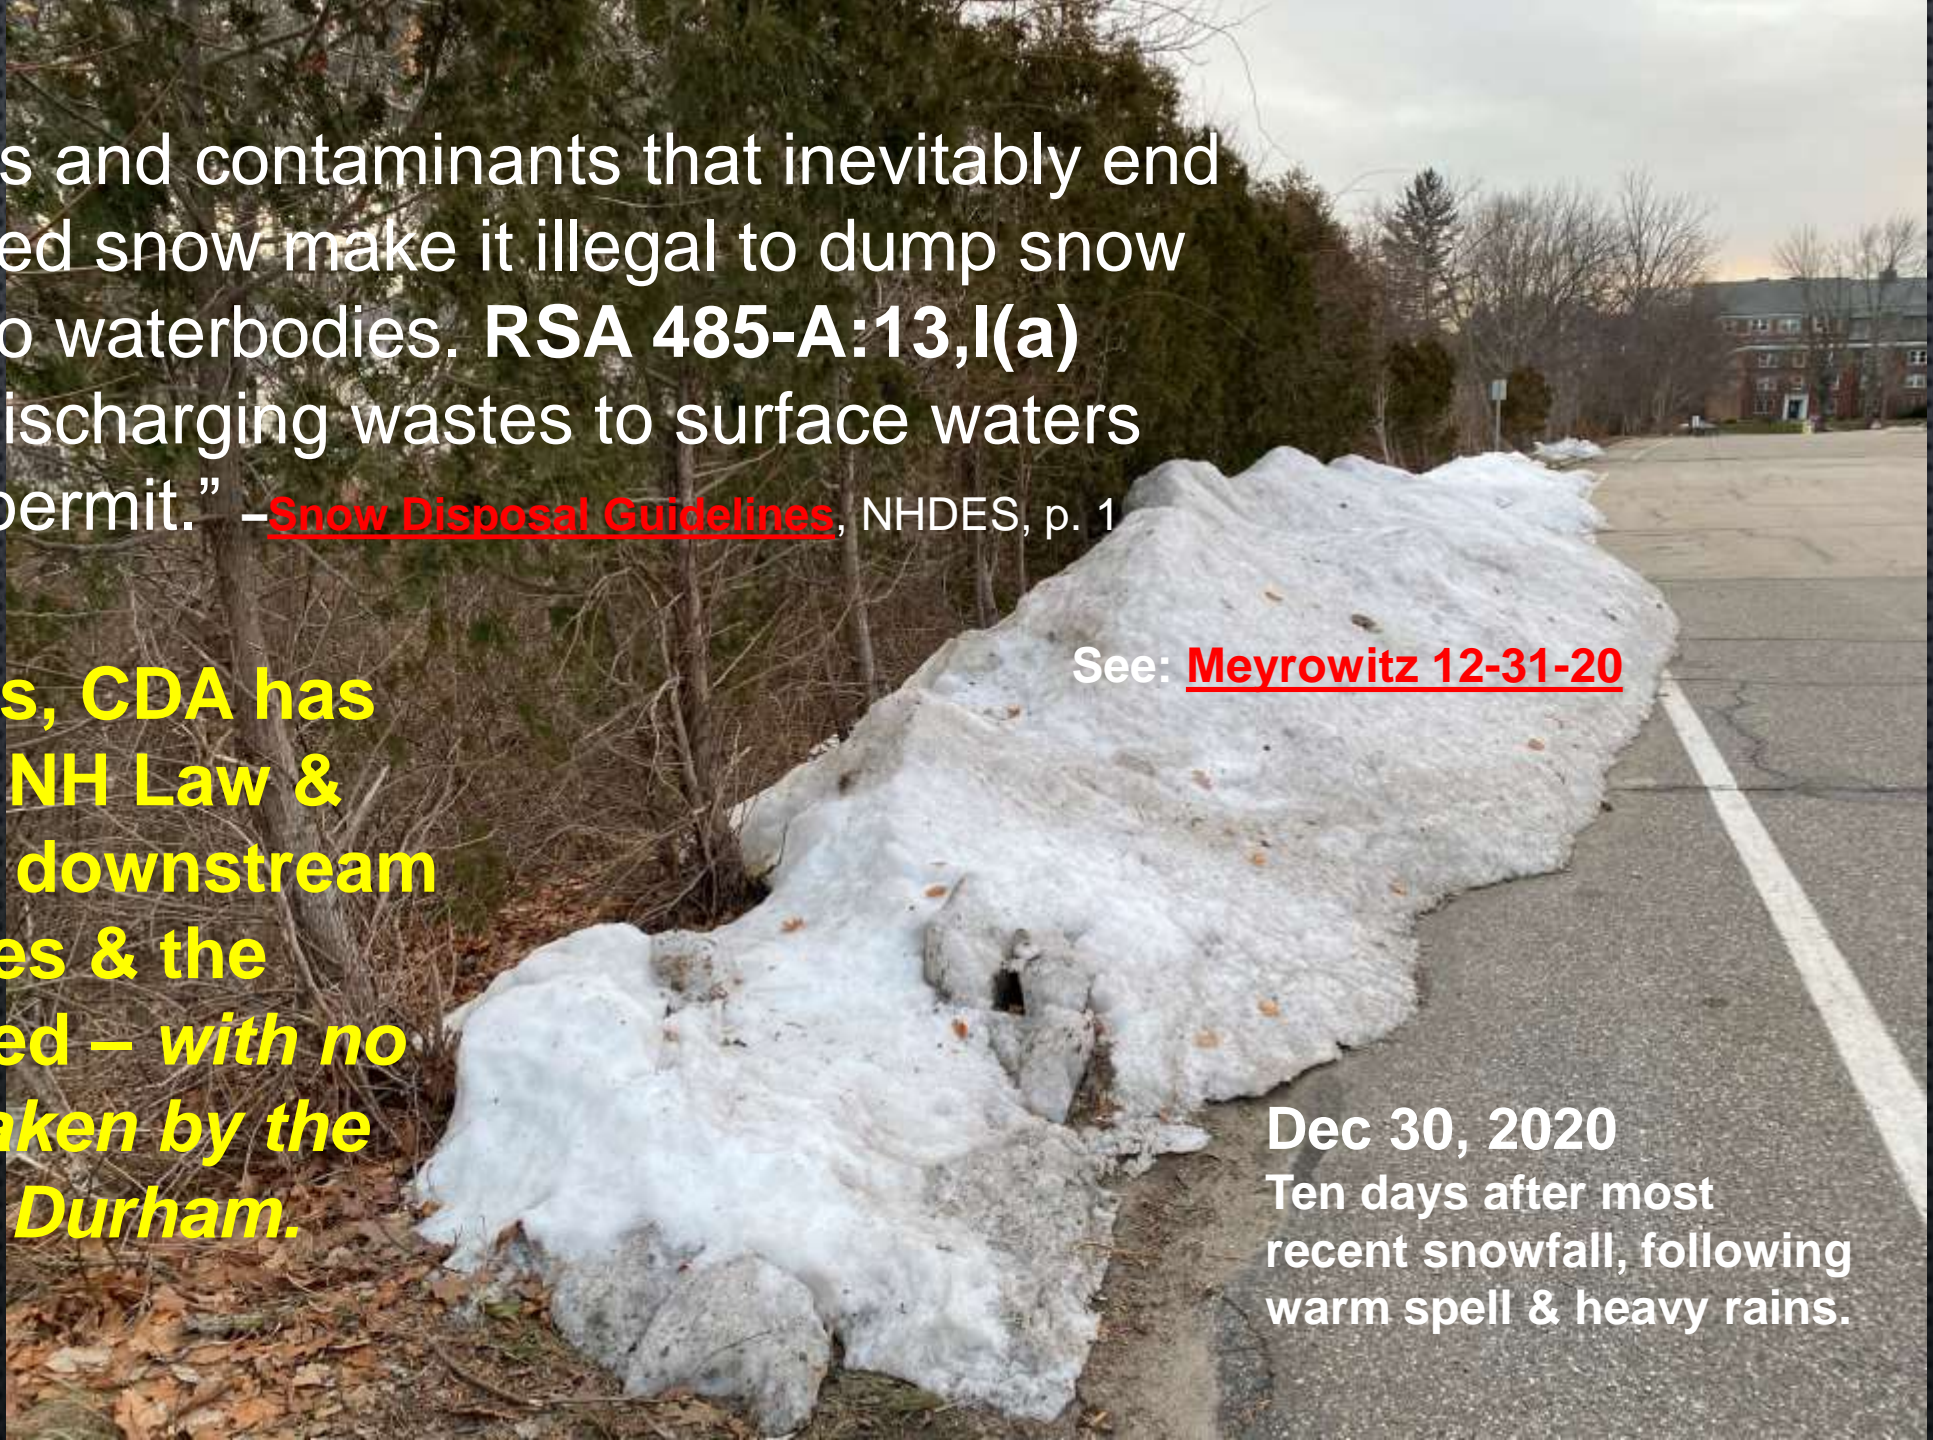
Dec 30, 2020
Ten days after most recent snowfall, following warm spell & heavy rains.

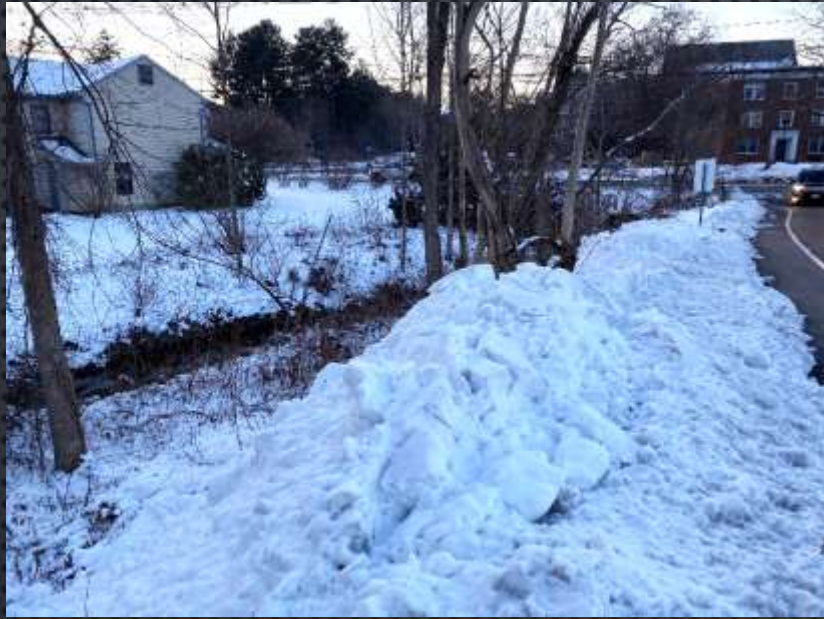
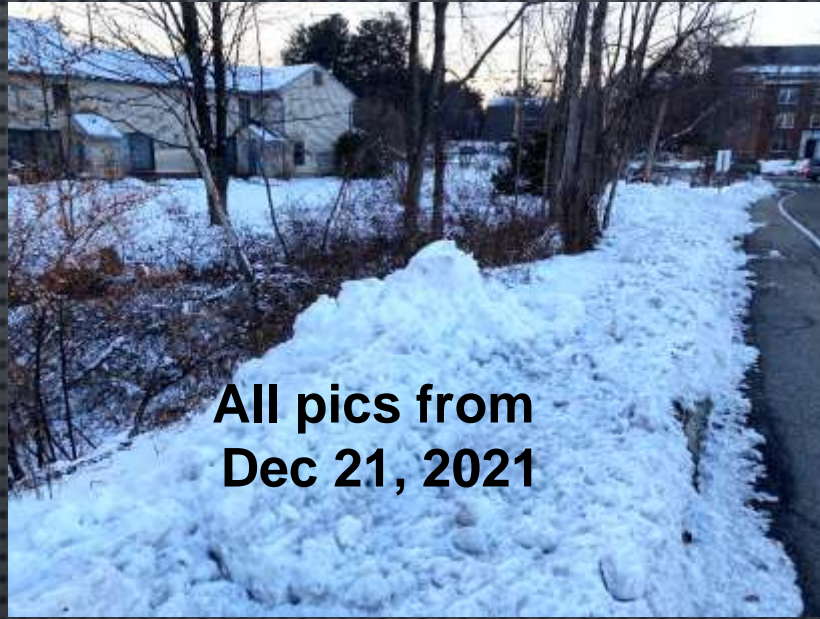
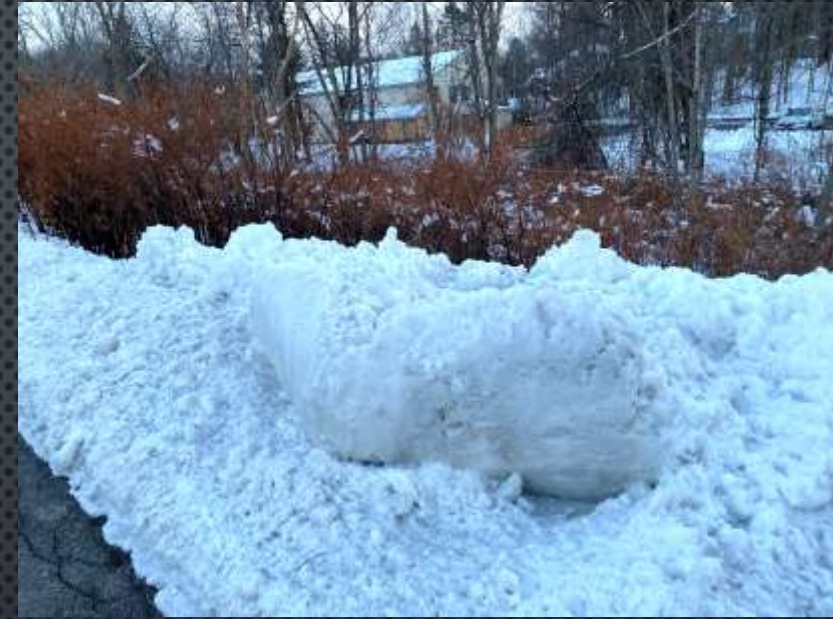
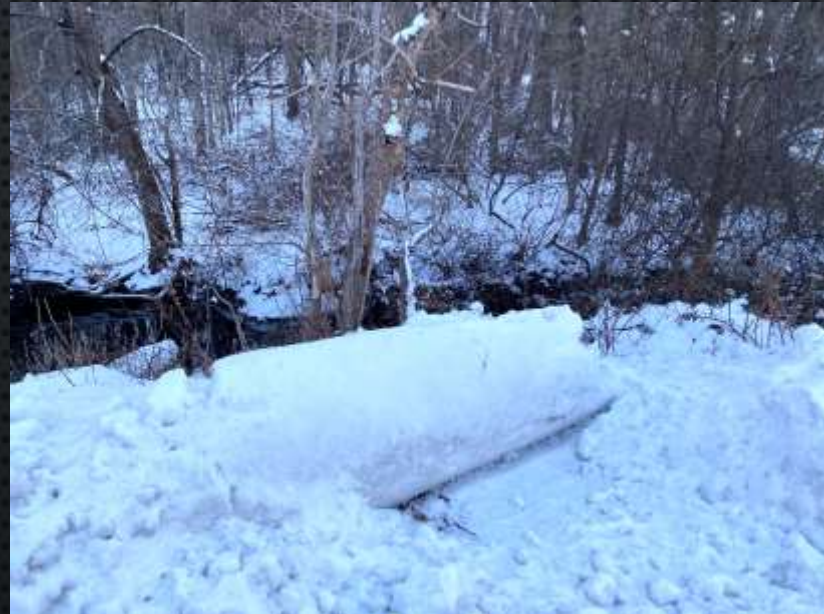
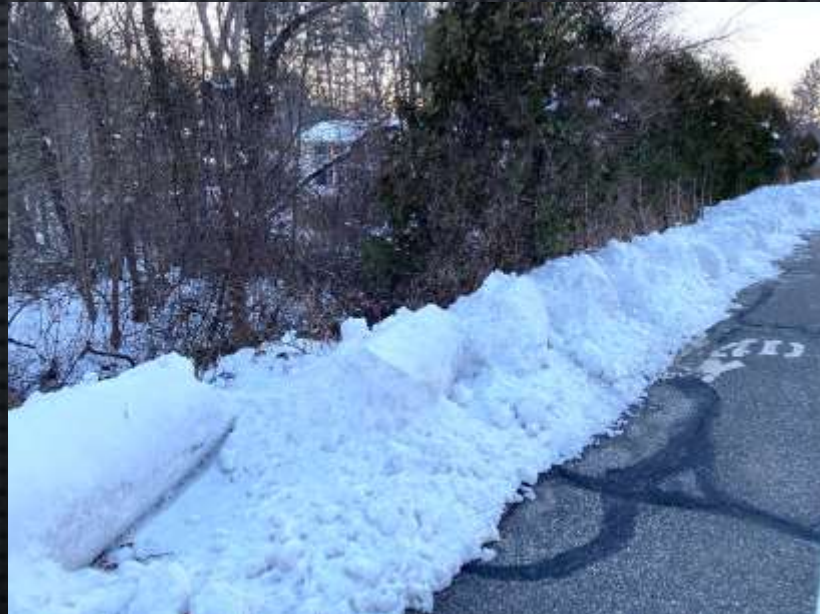
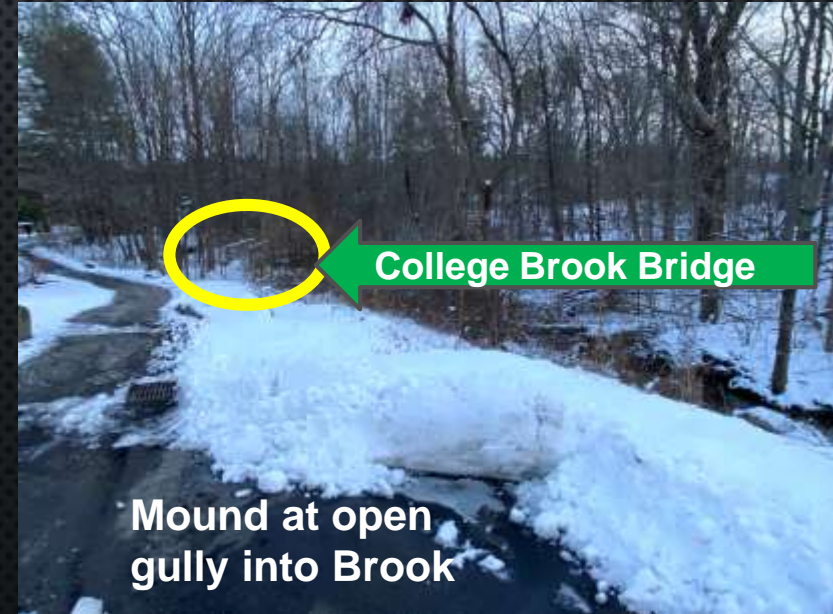
**All pics from
Dec 21, 2021**

Mill Plaza’s first-of-season illegal plowing into College Brook bank, Sun, Dec 19, 3:51 am
Violation of RSA 485-A:13,I (a) – “Water Discharge Permits” [NHDES LINK](#)

Mounds plowed as close to Brook as possible, with no place for snow to melt other than into watershed

**Mound at open
gully into Brook**

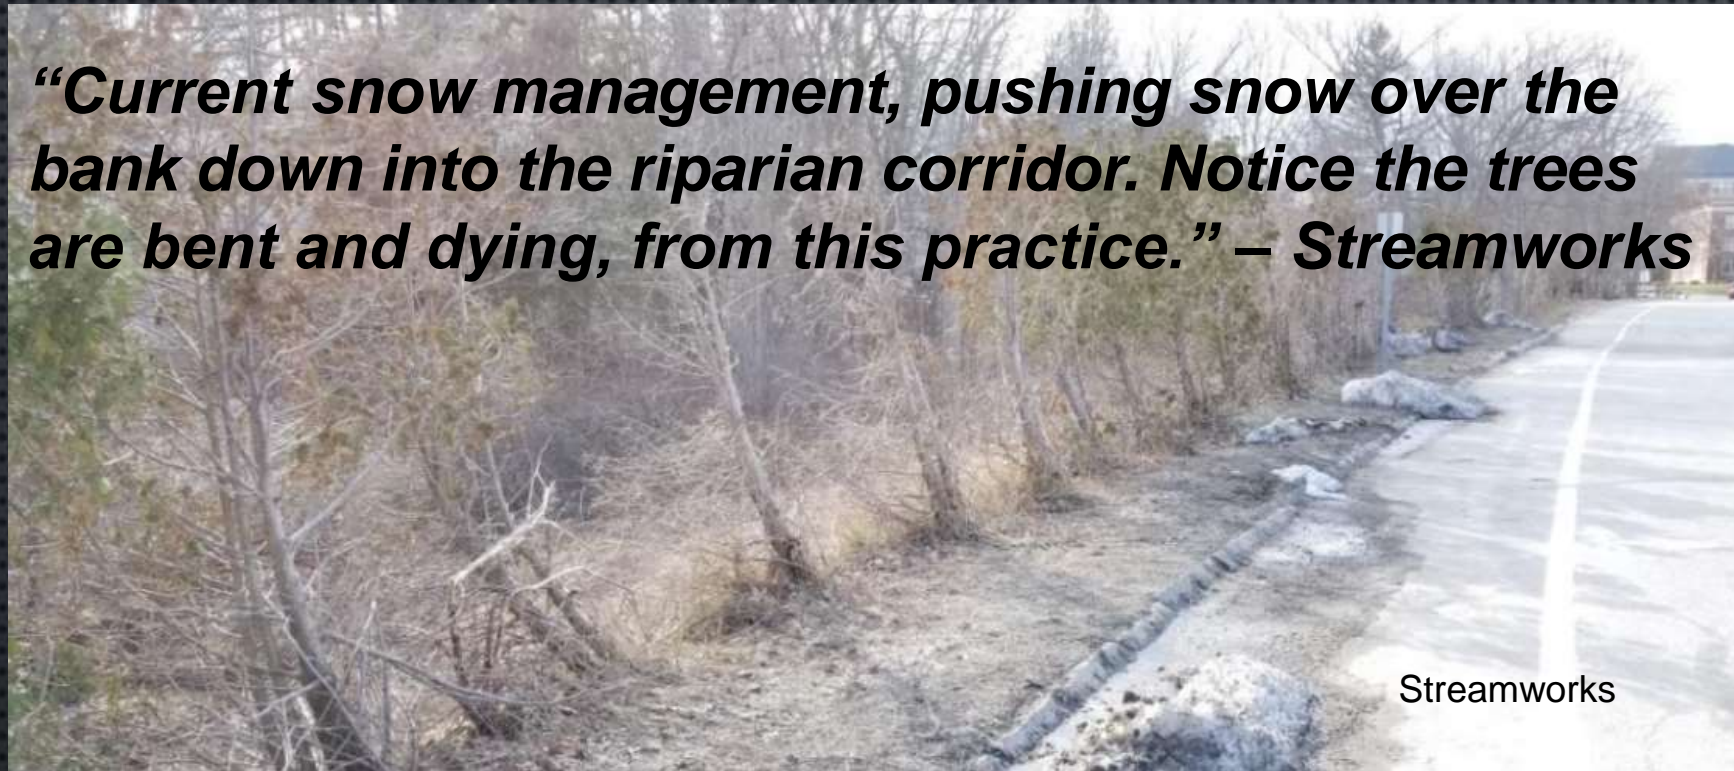
Active mismanagement documented even in *CDA-submitted [Streamworks Report](#)*

“Current snow management, pushing snow over the bank down into the riparian corridor. Notice the trees are bent and dying, from this practice.” – Streamworks

CDA’s promises to repair some of its own damage (broken curbing from plowing, trash in Brook, damage to trees) should not earn CDA approval of a still non-compliant site plan.

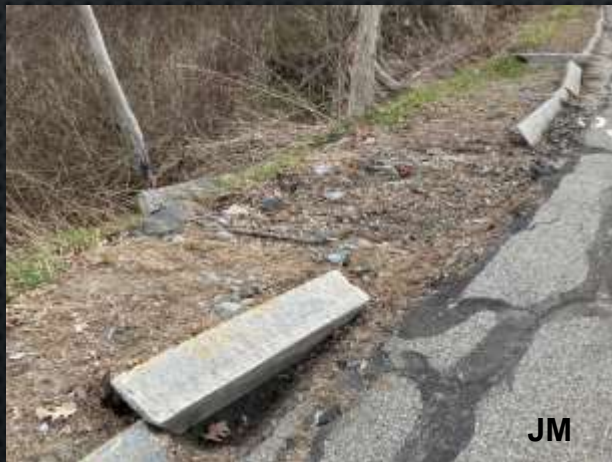
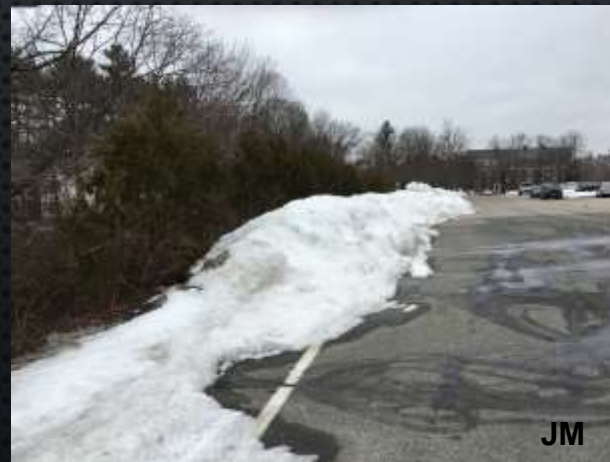
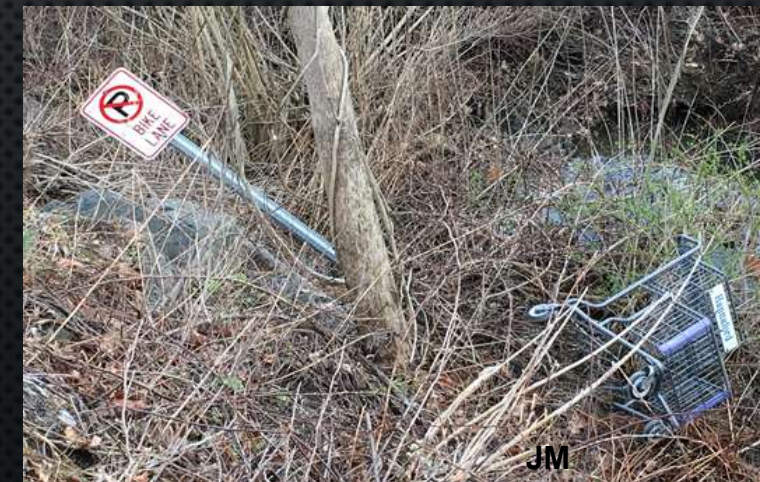
Most of the College Brook watershed is upstream of Mill Plaza, yet the Mill Plaza is unique in scale/density of impervious surfaces directly along & draining into brook

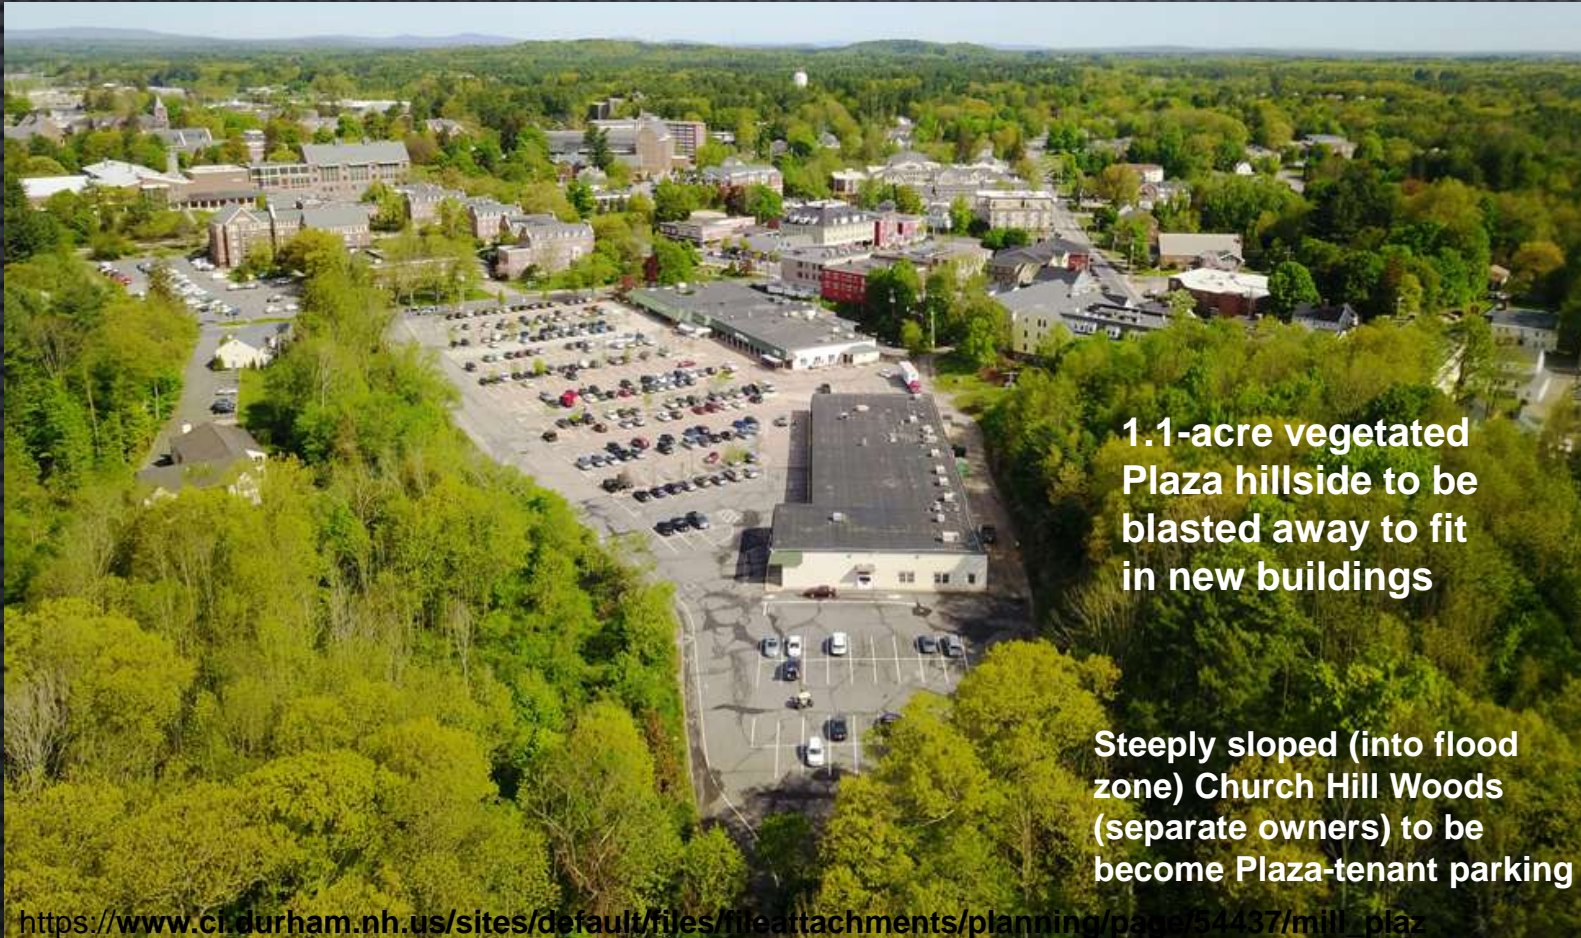
1.1-acre vegetated Plaza hillside to be blasted away to fit in new buildings

Steeply sloped (into flood zone) Church Hill Woods (separate owners) to become Plaza-tenant parking

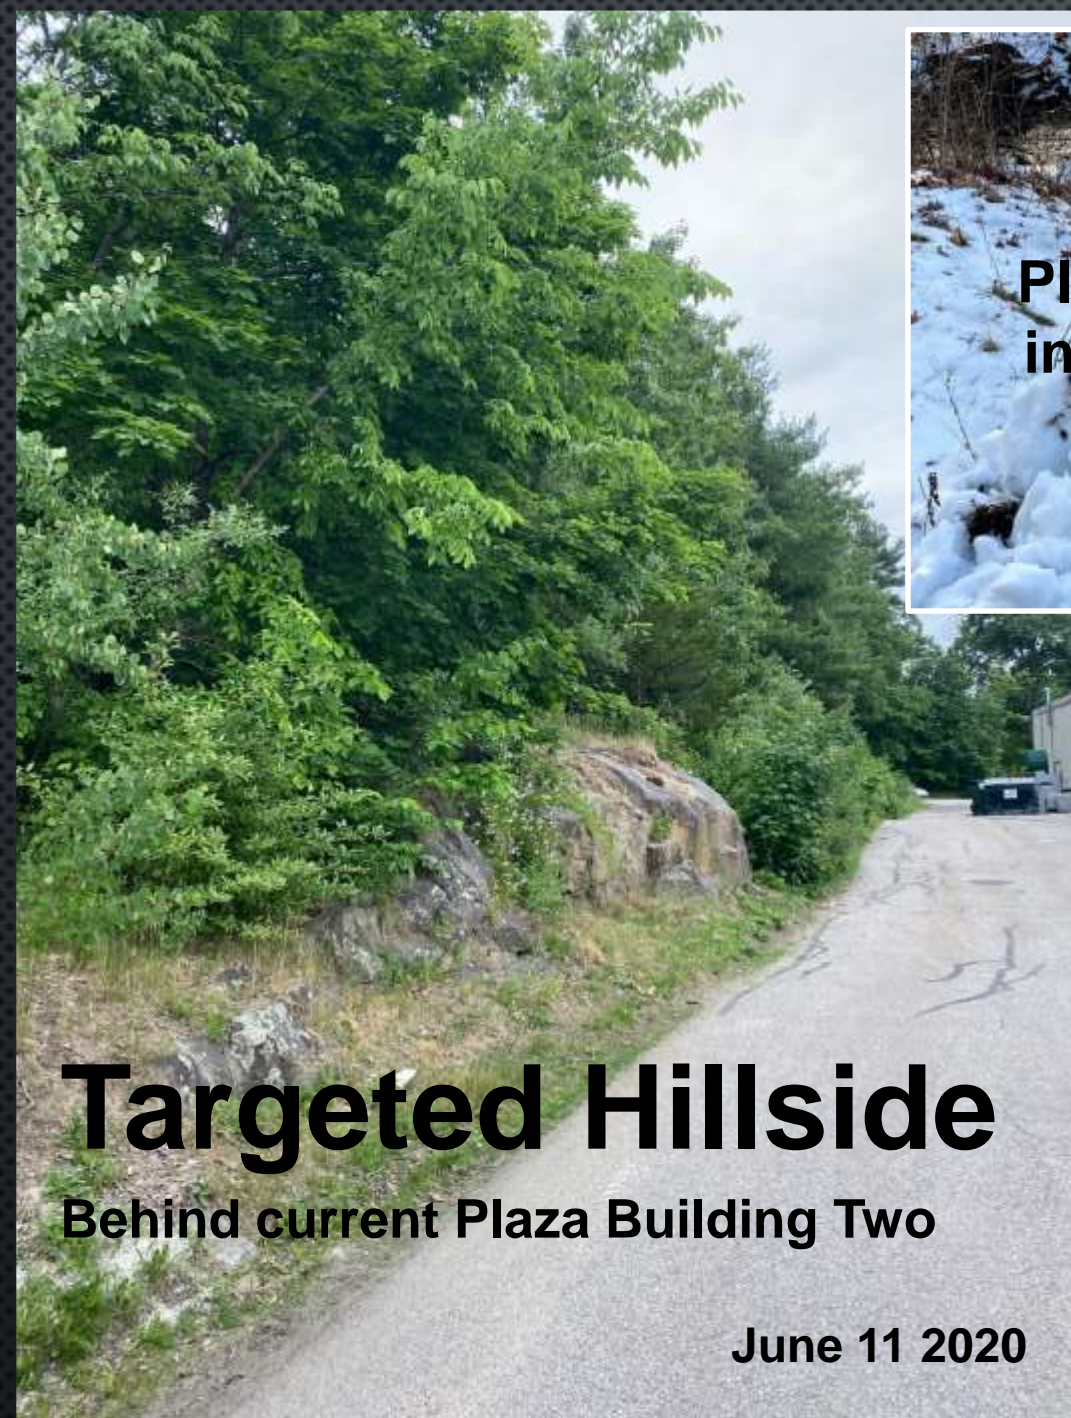
Targeted Hillside

Behind current Plaza Building Two

June 11 2020

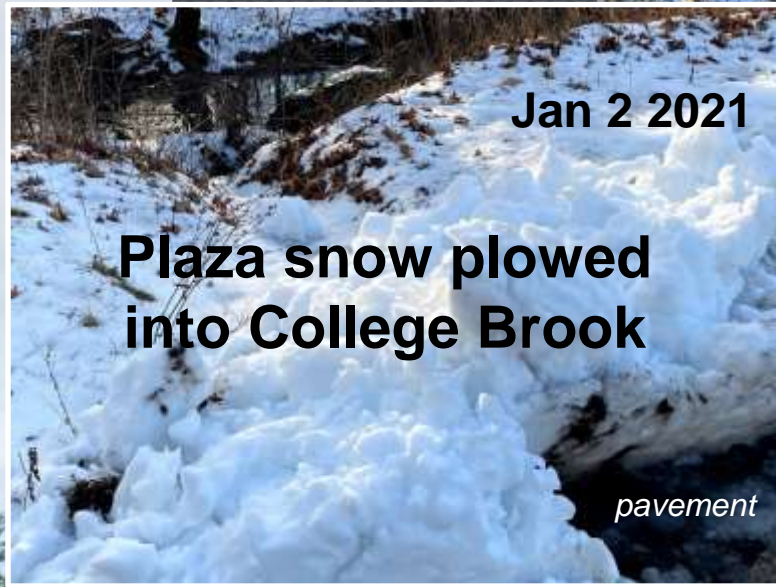
Jan 2 2021

Plaza snow plowed into College Brook
