## Damn those ice dams!

### **It's not Rocket Science, it's Building Science!**

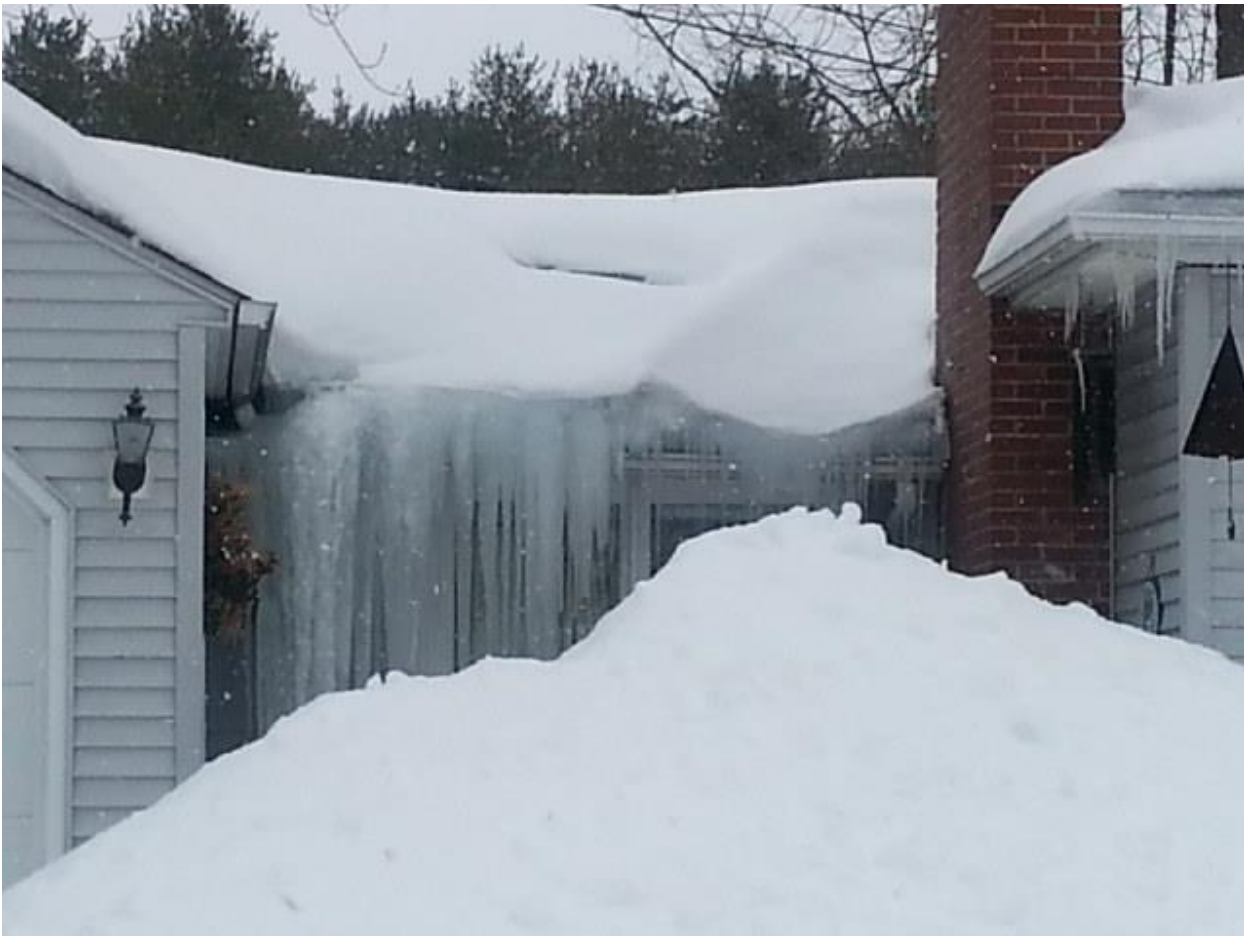
Ice dams form when heat escaping from the home warms the roof and melts the snow. The melt water trickles down the roof until it reaches the cold eave, where it refreezes. After some time, the ice at the eaves gets thicker, forming an ice dam. Water backs up behind the ice dam and eventually gets under the roof shingles, where it is free to leak through the attic and begin to damage ceilings, walls and floors. Ugh.

1. Installing a rubberized membrane under the roofing.
2. Improving ventilation between the top of the insulation and the roof sheathing.
3. Adding more ceiling insulation.
4. Sealing the air leaks between the warm interior and the attic or vaulted ceiling.

While the first two solutions are only treating the symptoms, the last two can reduce or eliminate the problem altogether. Qualified professionals, such as Weatherization Contractors, Energy Auditors and HERS Raters can diagnose and treat the root causes of ice dams and other building maladies. Trained in the principles of Building Science, such professionals receive many phone calls during cold, snowy winters from homeowners who are ready to stop wasting money on misguided roof repairs and shoveling injuries.

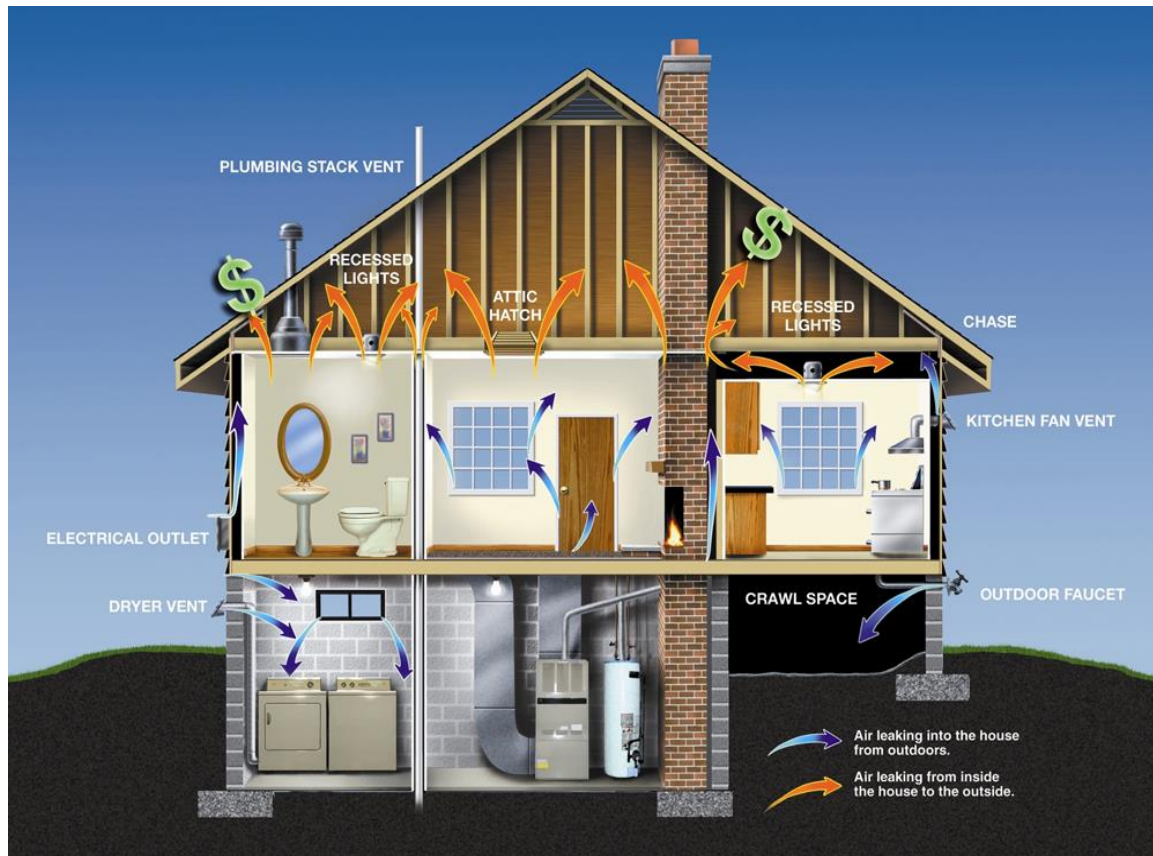
Ok, it's true. The attic can be a scary, dusty, hot, cold and generally uninviting part of your home. Fiberglass insulation is not sexy. It's itchy and sometimes covered with droppings of unidentified creatures. But flip it over and it tells a story. The underside of a fiberglass batt often shows a pattern similar to the surface on which it rests. Dark greyish marks are created by dust that has been filtered out of the warm air leaking into the attic from your interior below! Maybe it should be called "filterglass"...

Sealing these air leaks is the first priority in preventing ice dams. Air can leak into attics through recessed lighting cans, wiring, plumbing, fans, vents, wall frame top plates, attic hatches and chimney chases, to name a few.

Adding insulation can help once air sealing is complete. Check your local Energy Code requirements for R-values.
